# **Walked School Routes - Robert Blake Science College, Bridgwater**

**SA-8-0039-002-1**

**Admissions and Entitlements Team**

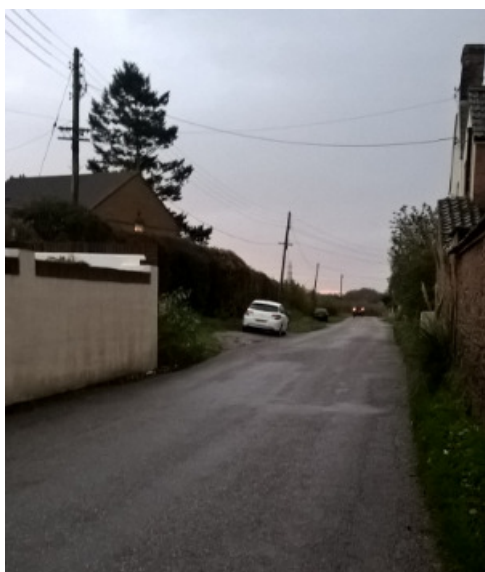
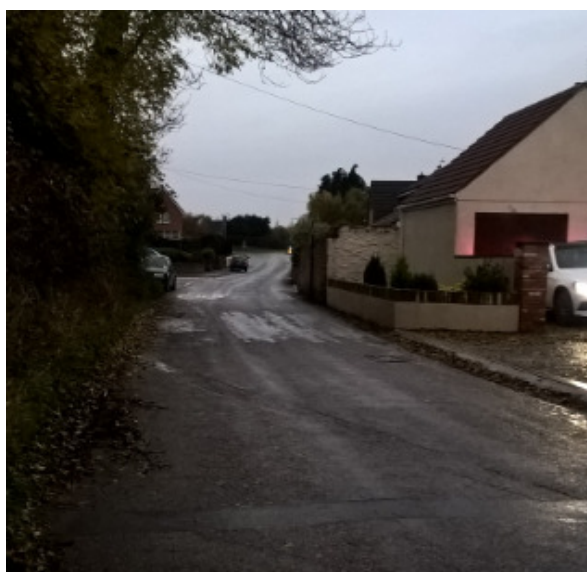
There was no footway outside Honeysuckle Mews. The RSO noted that at the time of inspection traffic flow was considered to be very low. Visibility was considered to be acceptable, based on the observed speed of traffic.

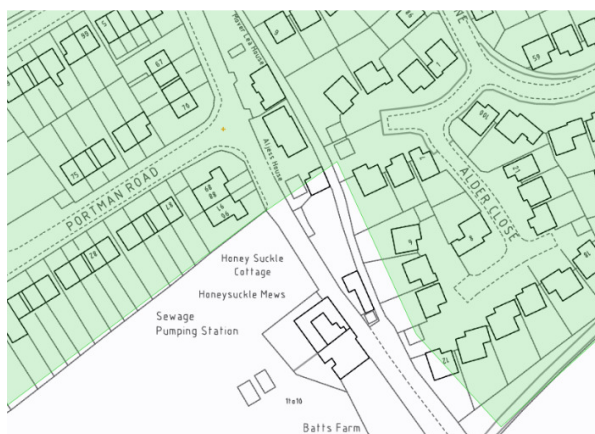
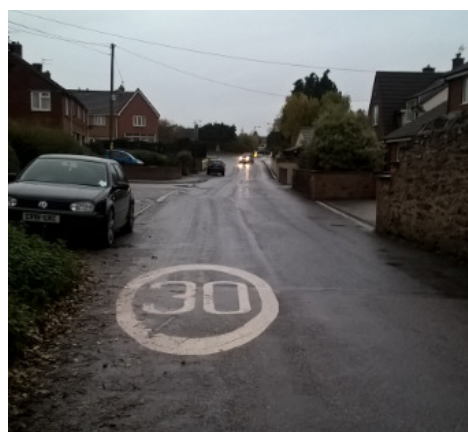
The inserted plan below shows the 30mph speed limit shaded in green.

The footway commences at the 30mph speed limit terminal signs. The RSO crossed Portman Road, then crossed Newton Road (at the school crossing patrol warning sign) to join the footway on the north easterly side of the road. The RSO crossed Baymead Lane using the pedestrian refuge (near junction with Dyers Green).

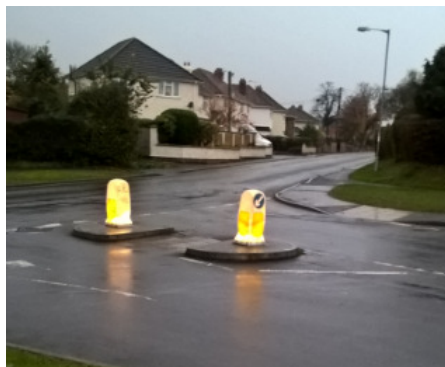
Continuing along Baymead Lane footway, the RSO crossed several minor roads (Mc Greath Close, Beggs Close, Baymead Meadow) most equipped with dropped kerbs and tactile uncontrolled crossing points.

The footway stops outside No.1 – The RSO noted a culvert running under the carriageway, at this point where the carriageway narrows to a single lane. Vehicles were observed to ‘give and take’. The RSO noted a grass verge, layby and edge line, provide pedestrians with the opportunity to step off the carriageway.

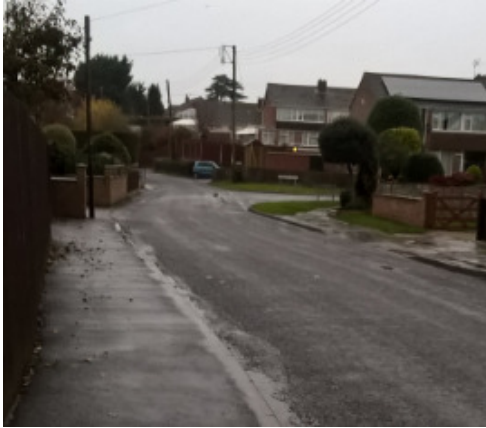
Continuing along the route, there is a short section of footway after the junction with School fields.

The RSO considered the very low traffic flow, visibility and short distance of walking in the carriageway to be acceptable.

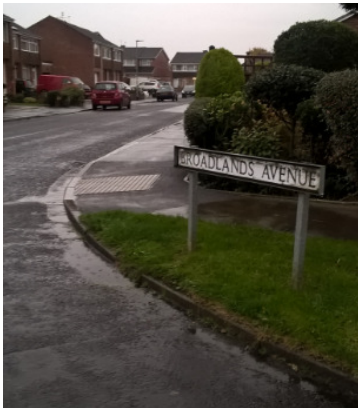
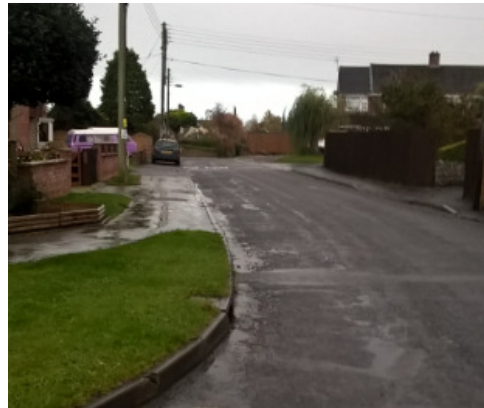
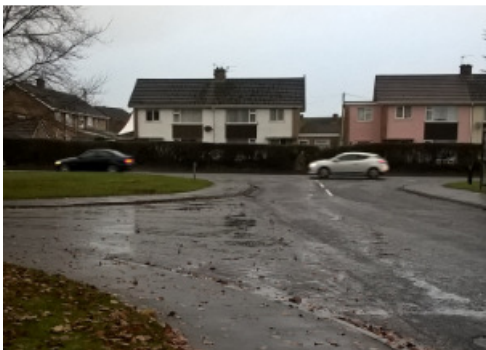
At the junction of Baymead Lane with Bridgwater Road A38, the A38 can be crossed via an uncontrolled pedestrian refuge. The A38 at this point has a heavy traffic flow in accordance with the definition contained within the RoSPA guidelines.

The refuge enables the pedestrian to cross the carriageway in two stages, thus aiding the availability of suitable gaps in each direction of traffic flow. The RSO observed traffic speed (30mph speed limit) and volume and considered visibility, to be in excess of 46m (Highway Code), at the crossing. Therefore, visibility was considered sufficient, to allow a vehicle to stop.

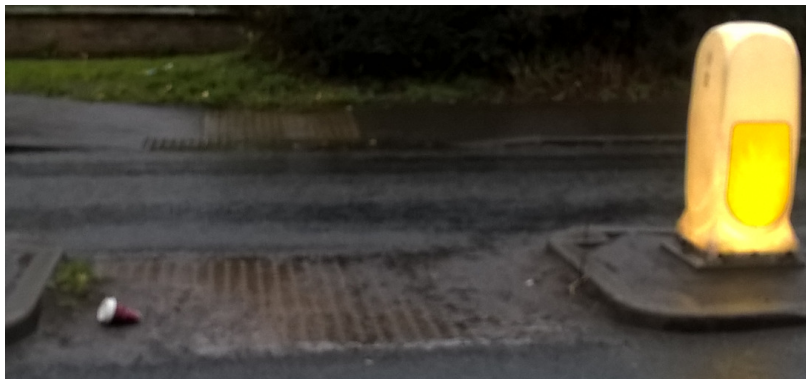
The RSO considered this facility to be adequate for normal pedestrian usage.

The uncontrolled pedestrian refuge (near Broadlands Avenue) is considered a suitable crossing in terms of the RoSPA guidelines. Considering a potential increase in pedestrian footfall using the refuge, it is possible that a controlled crossing may be more appropriate in the future. It is therefore recommended that the volume of pedestrians / traffic using the A38 pedestrian refuge in North Petherton is monitored. If pedestrian volumes significantly increase as a result of the walked route to school, it may be appropriate, in the future, to consider different types of controlled crossing at this site.

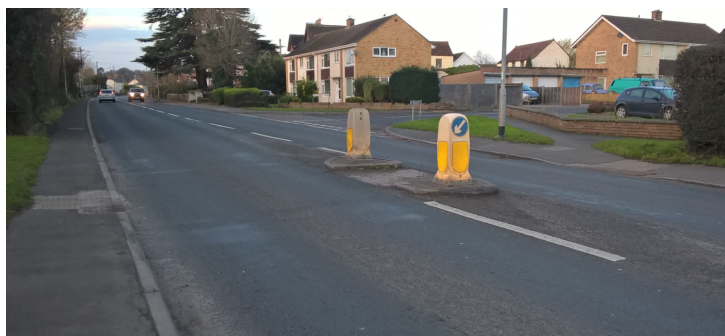
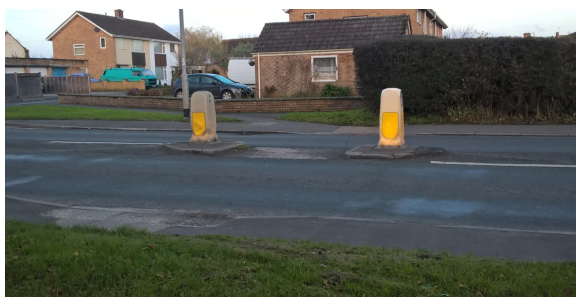
The traffic island width of 1.4m and carriageway width of 3.2m afford reasonable lateral clearance between traffic and pedestrians. The RSO did not observe any pedestrians using the crossing at the time of the inspection.

The RSO continued along footway on westerly side of A38, to the bus stop and junction to Clavelshay. Crossing Old Road to join a segregated (cycle and pedestrian) route. Pedestrians are adjacent to the highway boundary, affording suitable lateral clearance between the pedestrians and traffic.

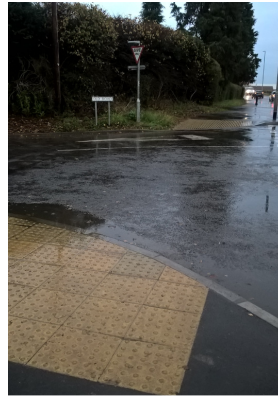
The RSO noted that the speed limit remains at 30mph and is signed with 30mph and safety camera signs at this point.

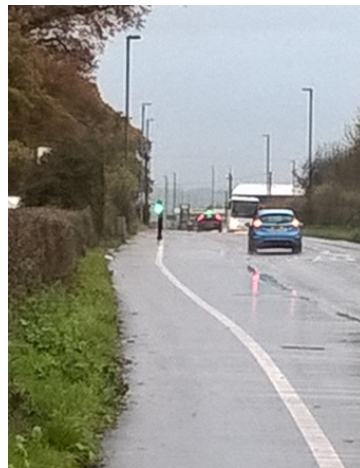
Approaching the signalised junction to 'Sedgemoor Auction Centre' traffic speeds were observed to be controlled and slow. Cyclists and pedestrians were witnessed using the route.

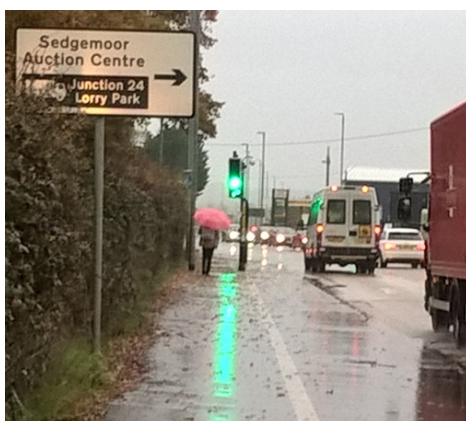
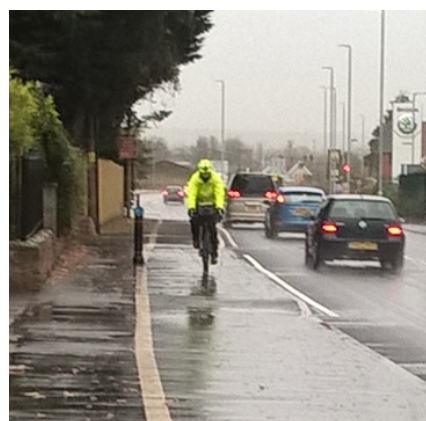
A new junction is being constructed opposite 'The White Willow' and 'Skoda garage'. At the time of the inspection the crossing was uncontrolled and the new side road closed to through traffic. This junction will be signalised and incorporate a controlled crossing for pedestrians and cyclists in the future.

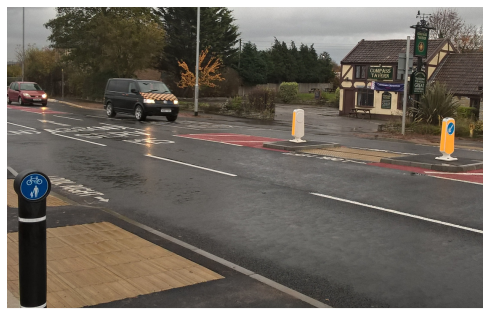
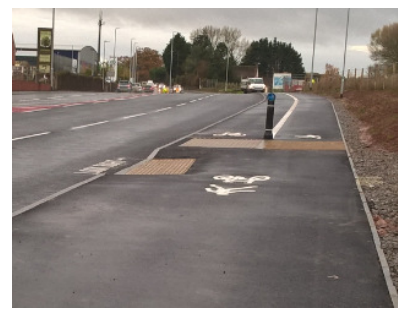
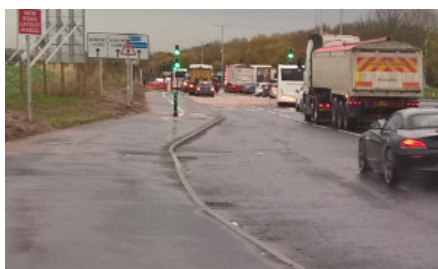
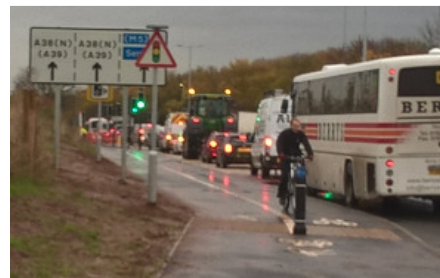
Approaching Huntworth Roundabout the RSO observed the uncontrolled pedestrian island outside of the Compass Tavern, and two lanes of traffic north easterly bound. At this point the route becomes shared. No longitudinal safety line is provided to define an area of lateral clearance between non-motorised users and traffic. It was also noted that other lines were missing associated with a bus stop. It is recommended that necessary road markings be provided; this will be considered by the Stage 3 Road Safety Auditors. The segregated route recommences at the get in lane signs in advance of the roundabout. Terminal signs inform motorists that they are entering a 40mph speed limit. The RSO observed both pedestrians and cyclists using the route.

At the time of this inspection works were being carried out to re-align the pedestrian route across the roundabout splitter island. An additional inspection of this section of the route was carried out following completion of the road works. The RSO crossed with caution and continued along segregated route adjacent to the A38.

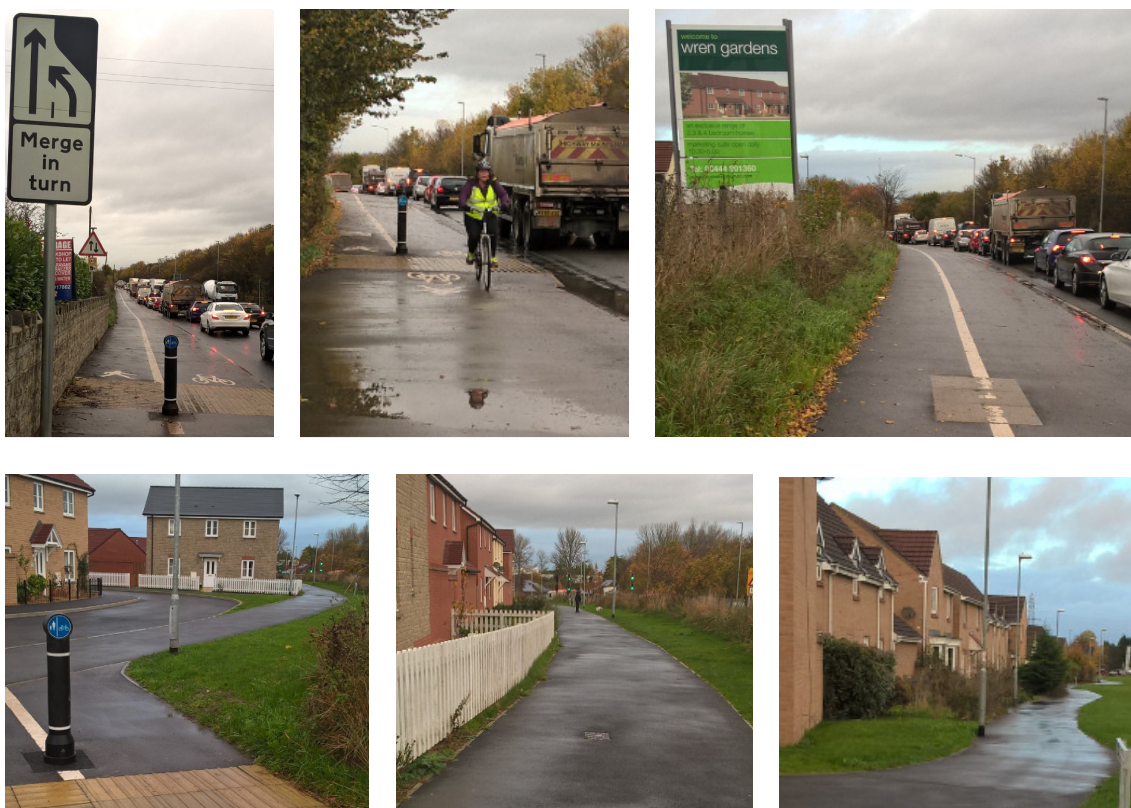
Traffic merges from two lanes down to one lane. Traffic queues are formed and traffic moves at a crawling pace. At Wren Gardens the RSO observed cyclists and pedestrians using the route. The footway diverges into housing estate via 'Phoebe Walk' and continuing into 'Chantilly Walk' and 'Stockmoor Path' segregated from A38 traffic.

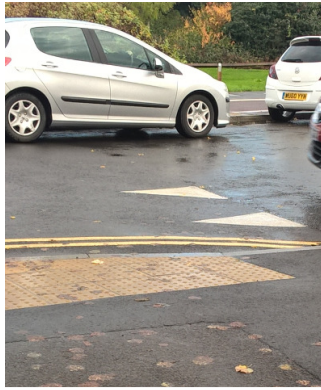
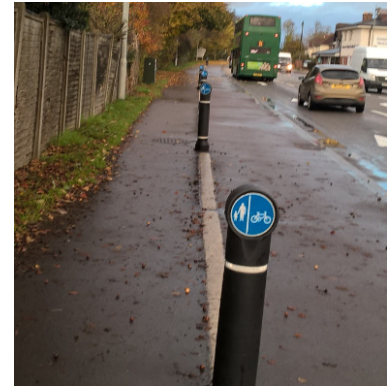
At 'Showground Roundabout' the RSO crossed at the uncontrolled crossing, located on a 'table top' traffic calming feature. Young people accompanied by adults were observed using this section of the segregated route. Over a short length of route, bollards have been utilised to provide a physical separation / reminder to NMUs.

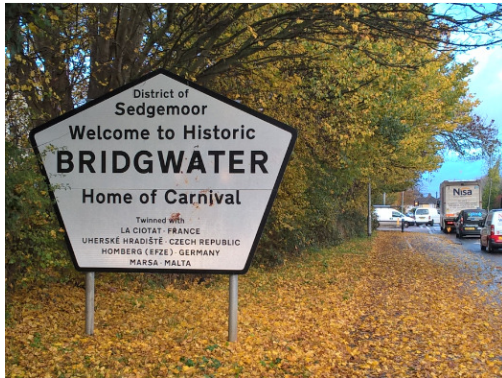
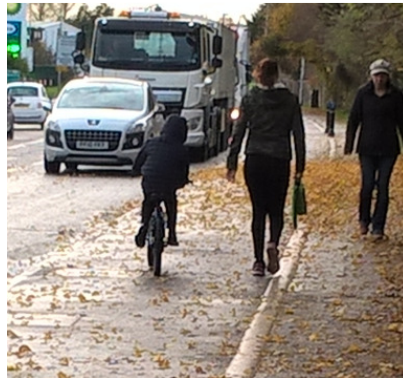
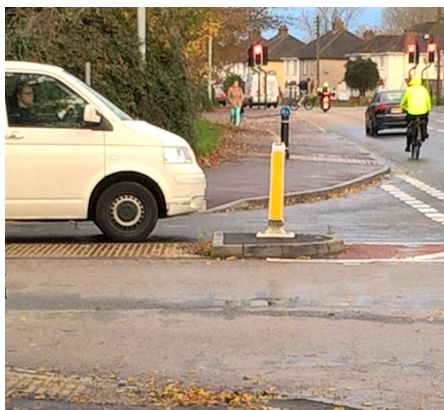
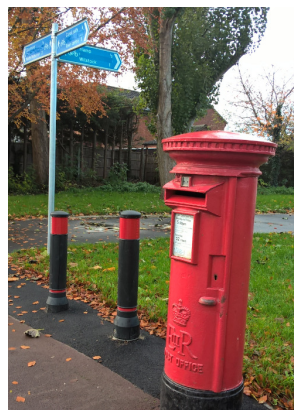
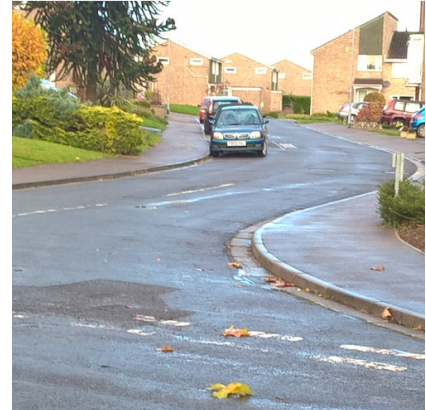
Approaching Bridgwater, the RSO observed the town name plate sign and pedestrians using the route. The RSO crossed Wills Road and continued to Ringwood Road / Chepstow Avenue. Traffic flow on the residential streets was very low.

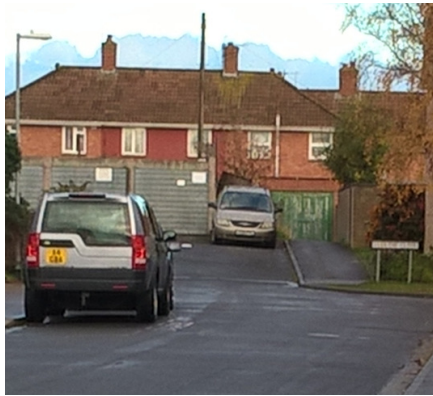
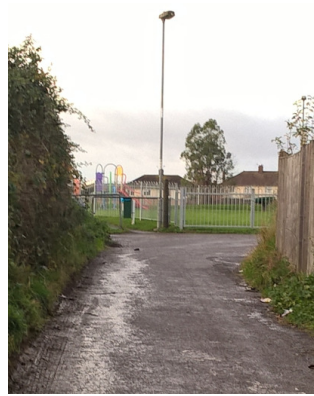
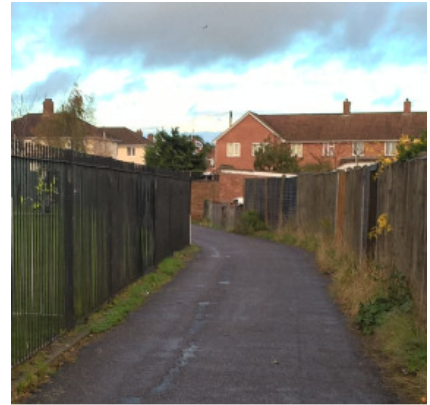
The RSO continued through the estate roads and at the junction with Ludlow Close linked to the footpath adjacent to 'Mansfield Playing Field'.

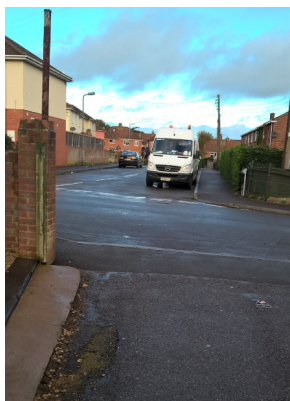
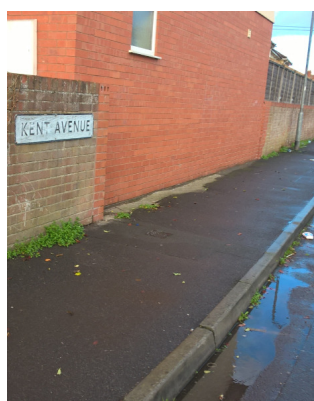
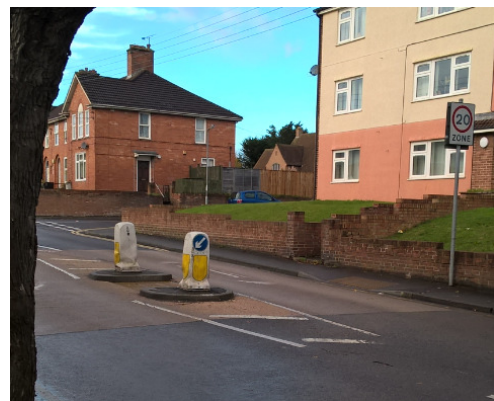
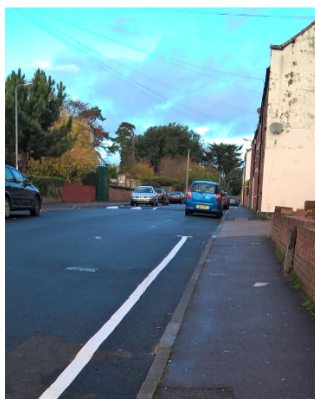
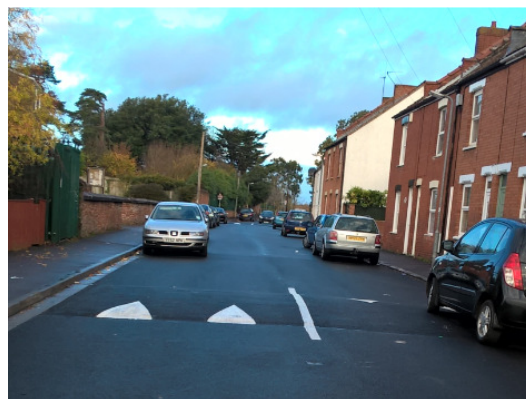
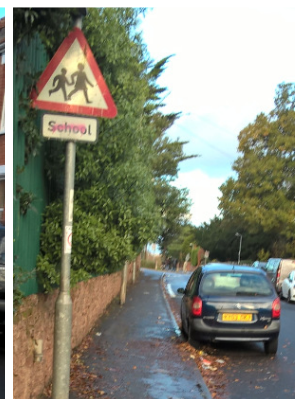
The RSO continued on footways negotiating residential streets – Playstone Avenue, Kent Avenue, Rhode Lane and Hamp Street arriving at Robert Blake Science College at 09:02hrs.

The RSO observed traffic calming and associated 20mph zone outside of the school. Traffic flows and speeds appeared to be very low and suitable crossing points available to cross roads.

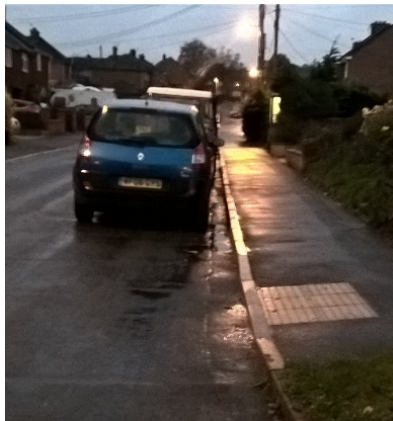
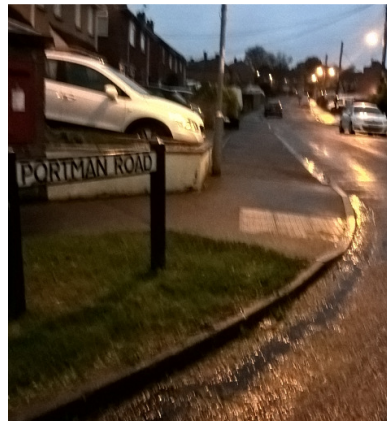
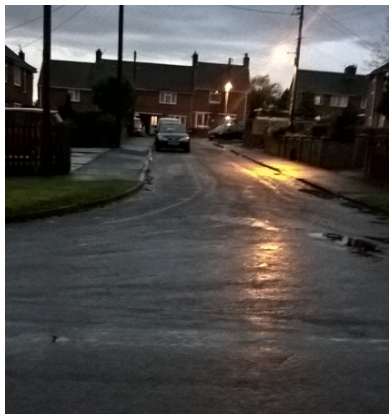
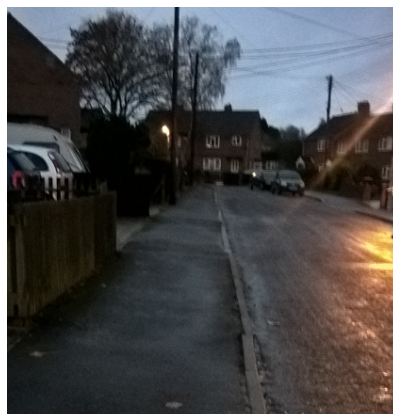
An assessment was carried out on Friday 18<sup>th</sup> November 2016. There was slight rain and the road surface was wet at the time of the inspection. The walked route commenced at 07:13hrs along Portman Road, North Petherton. There are footways on both sides of the residential streets and on street parking. The RSO crossed over minor side roads.

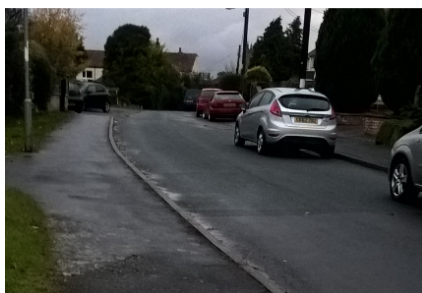
The footways discontinue. Pedestrians were observed using this section of the route. The RSO noted a very low traffic flow and considered visibility to be acceptable.

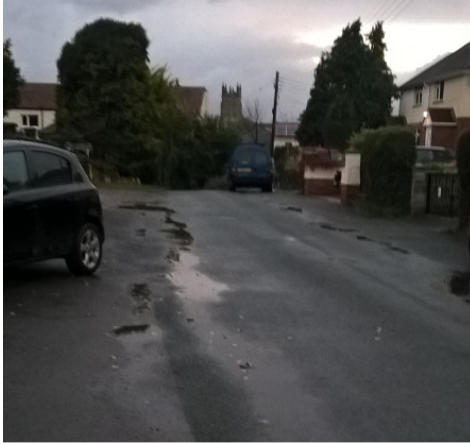
The pedestrian footway continues on the offside around a right hand bend and on to the left hand bend where the footway switches to the inside of the bend.

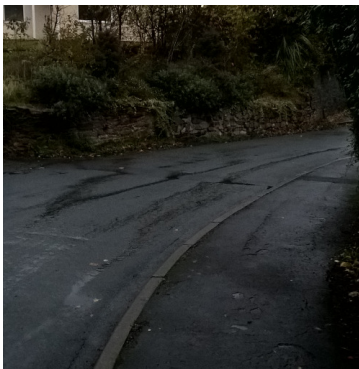
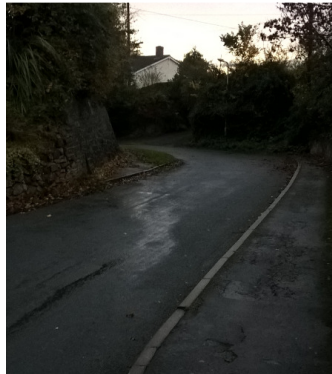
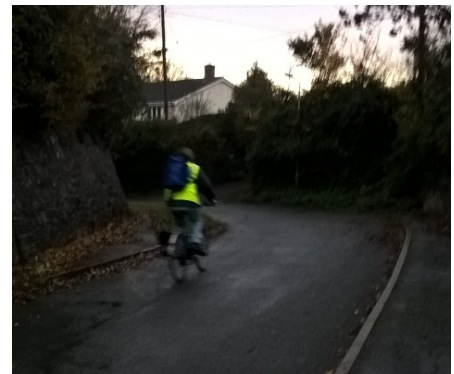
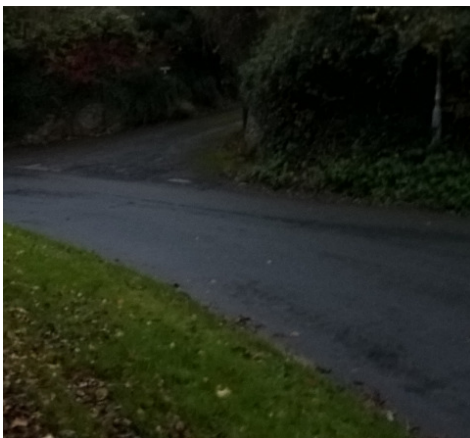
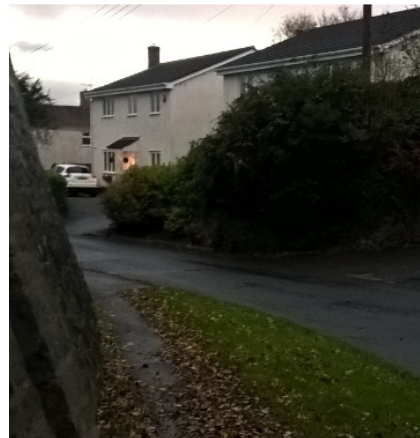
The footway discontinues for a short length, pedestrians walk in the carriageway. The RSO considered traffic flow and speeds to be low. Visibility was considered to be acceptable.

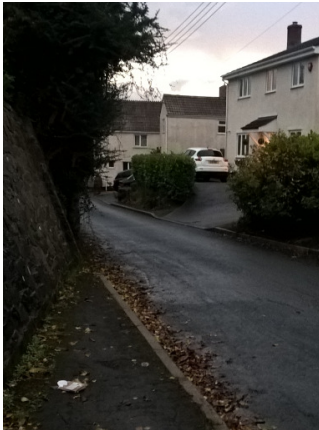
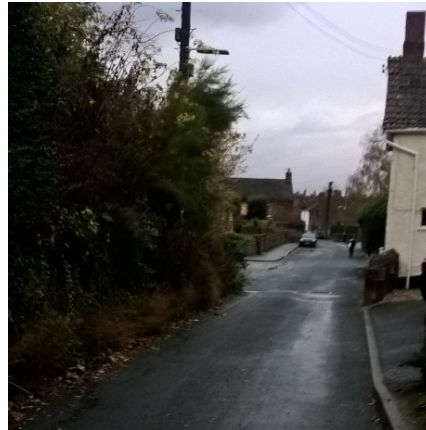
The RSO crossed over the minor road of Crosswell Close. The footway continues to North Petherton Community Primary School. From this point the RSO walked in the carriageway.

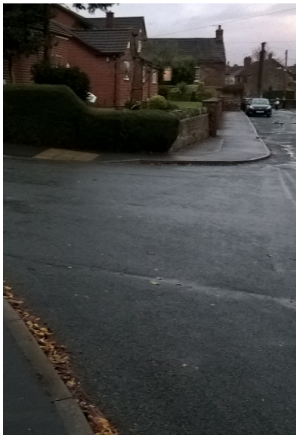
The RSO noted on street parking and very narrow streets. Traffic flow and speed was very low at the time of the assessment. The RSO considered visibility to be acceptable and noted that the occasional vehicle passed.

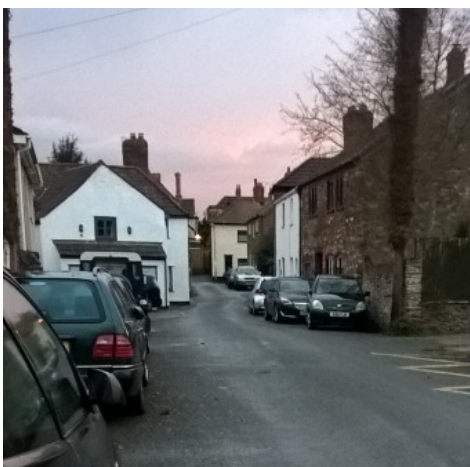
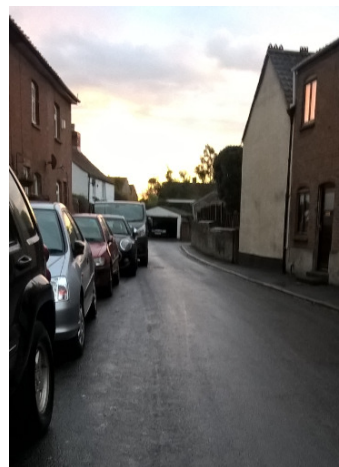
The road bends around to the right, narrow footways and on street parking on Mill Street.

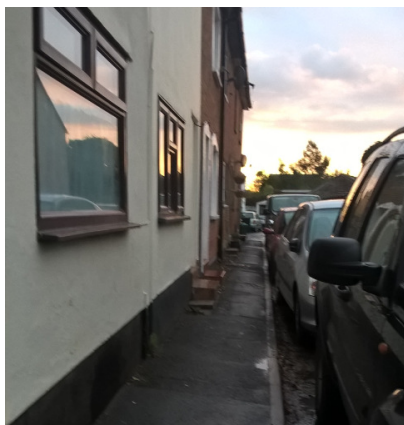
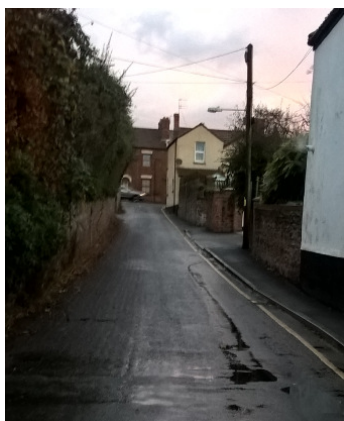
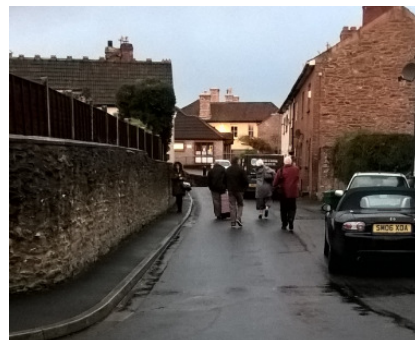
Turning left at the end of the street, the RSO proceeded towards the junction with the main road (A38). A footway on the offside terminates. An offset yellow line provides a pseudo footway for approximately 20m, to link with near side footway.

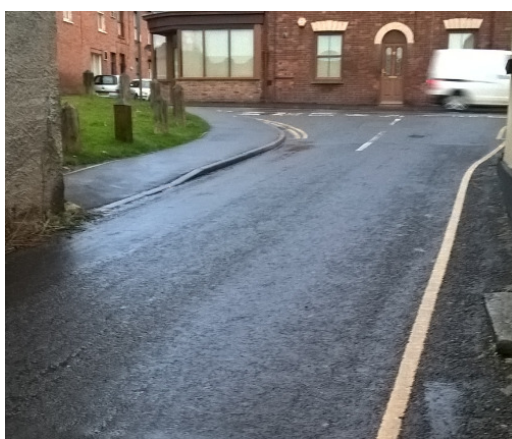
The RSO considered that this section of the route to be a 'non-hazardous walking route' in accordance with the RoSPA guidelines.

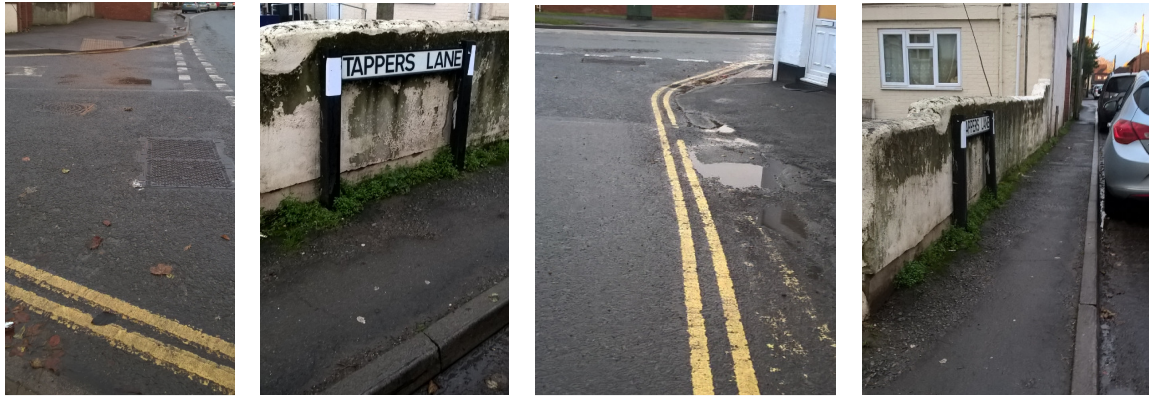
The RSO crossed a side road (Hyde Park Avenue) and continued along the route, via a footway to junction with Shovel Lane.

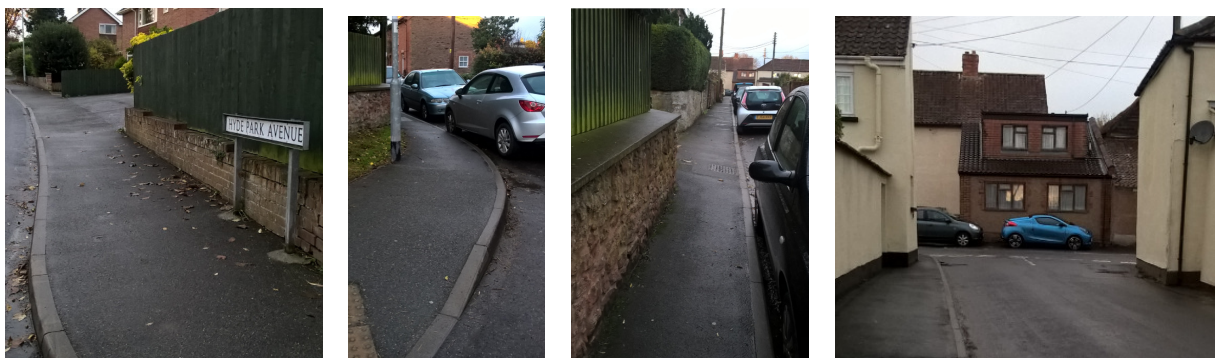
Crossing over Shovel Lane and continuing into Cliff Road. Minor roads (Brook Close), crossed, the RSO considered the traffic flow to be very low and visibility acceptable.

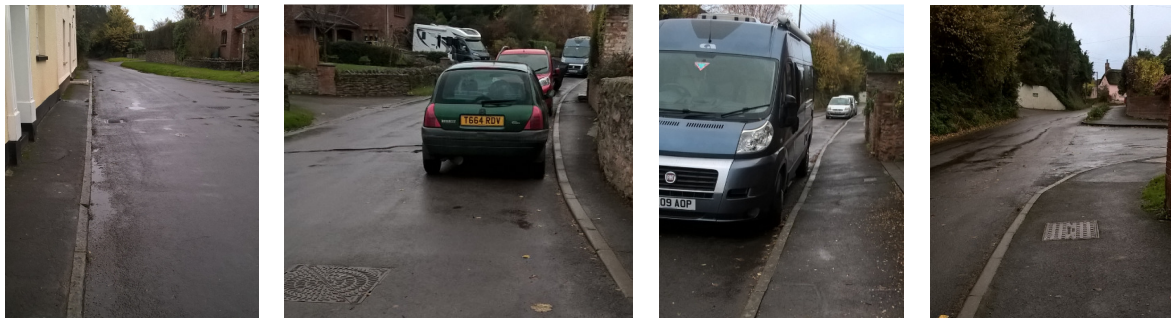
The footway terminates at the junction of Cliff Road with Hulkshay Lane (no through road). Walking along Hulkshay Lane, the RSO did not observe any traffic, visibility was considered acceptable.

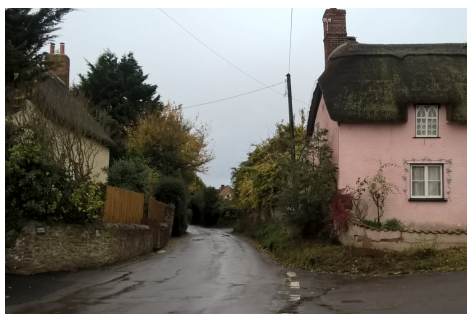
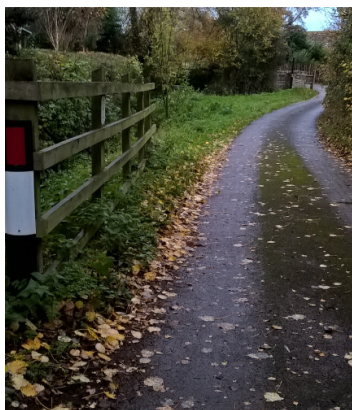
Returning to Cliff Road, the RSO observed a pedestrian (and runners) using the route. Vehicles passed with caution and afforded sufficient lateral clearance.

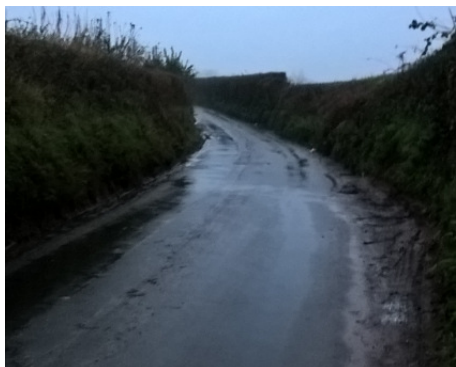
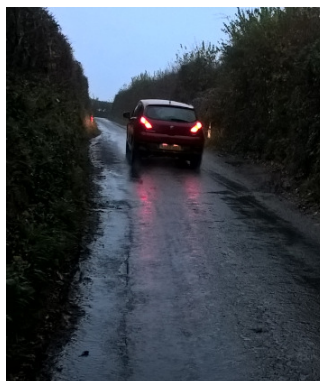
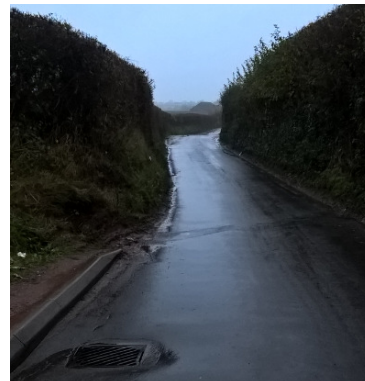
The walked route commenced in a country lane with no surrounding properties. It is recommended that the School Assessment Team re-consider the extent of the route length, as the western end of Dancing Hill is single track road, bound by hedges with no available step offs. There are bends in the road (near the Woolmersdon and Durleigh junction) that reduce visibility between traffic and pedestrians.

It is recommended that the route commences near Dancing Hill Farm entrance, where step offs become available for pedestrians. The RSO noted from Dancing Hill Farm there is a verge on the near side and the carriageway bends around to the right.

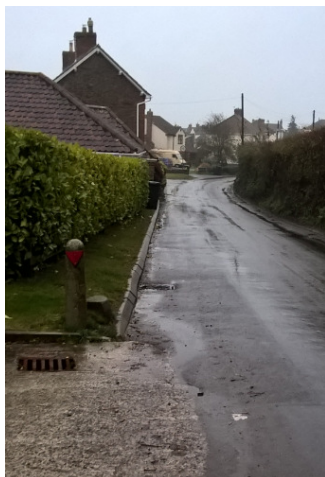
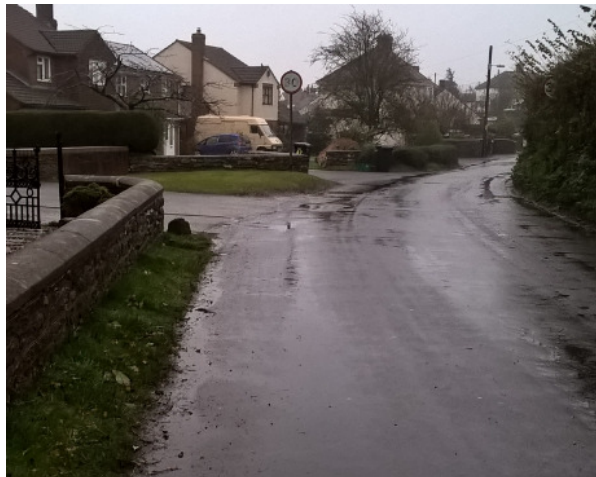
The 30mph speed limit terminal signs define the limits of the restricted road status. Driveways provide regular step offs and a junction to Clavelshay.

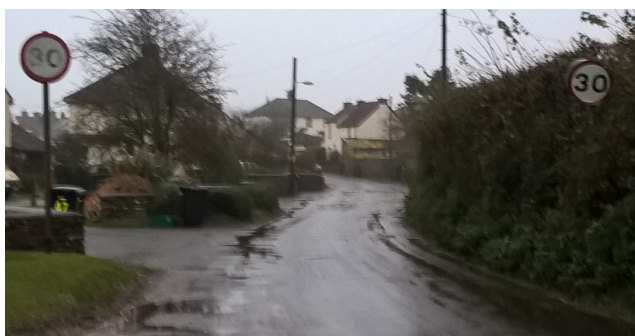
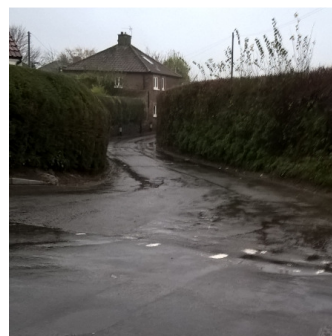
Continuing the route along North Street, there is a left hand bend. The near side is bounded by a wall. Further along the route there are walls bounding both sides of the carriageway. The RSO considered the traffic flow to be very low and there to be sufficient visibility and room for vehicles to pass.

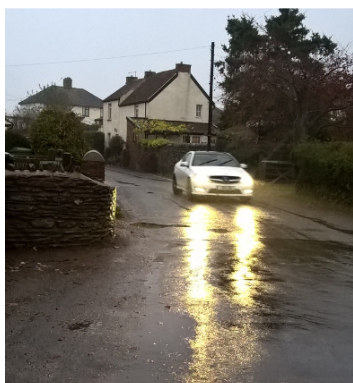
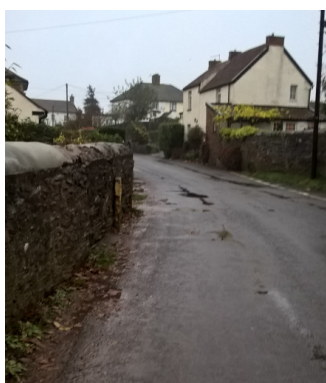
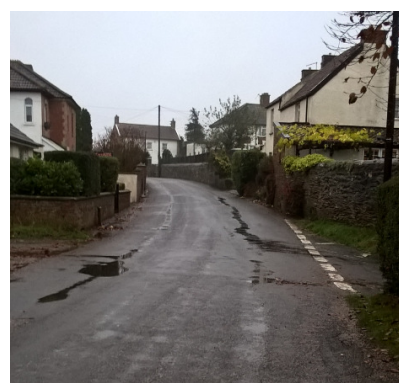
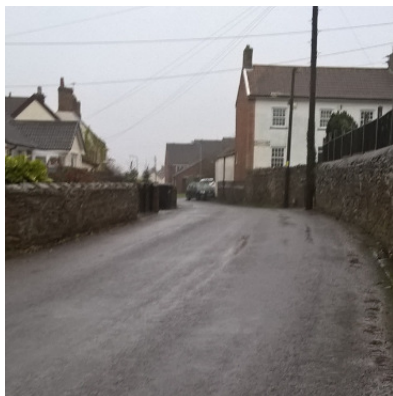
The RSO noted a lane (Pilots Helm) off to the right. There is a narrow verge on the offside leading to a footway.

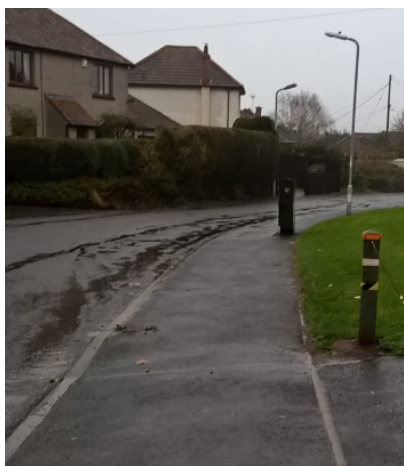
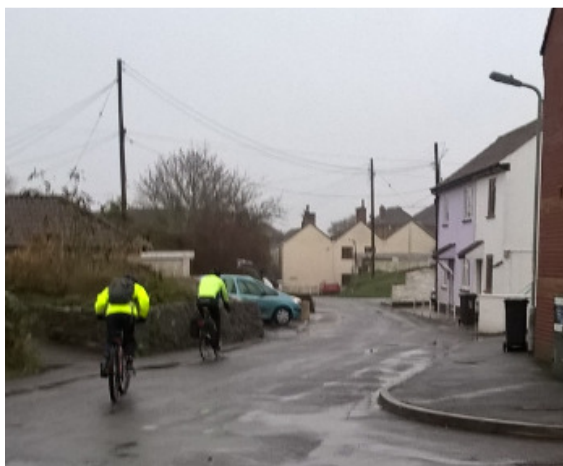
Crossing a side road (Ivors Way) the RSO noted an adult accompanying a young person on a cycle. The RSO continued along the footway crossing side roads (Clarence Street, Queens Street) as necessary.

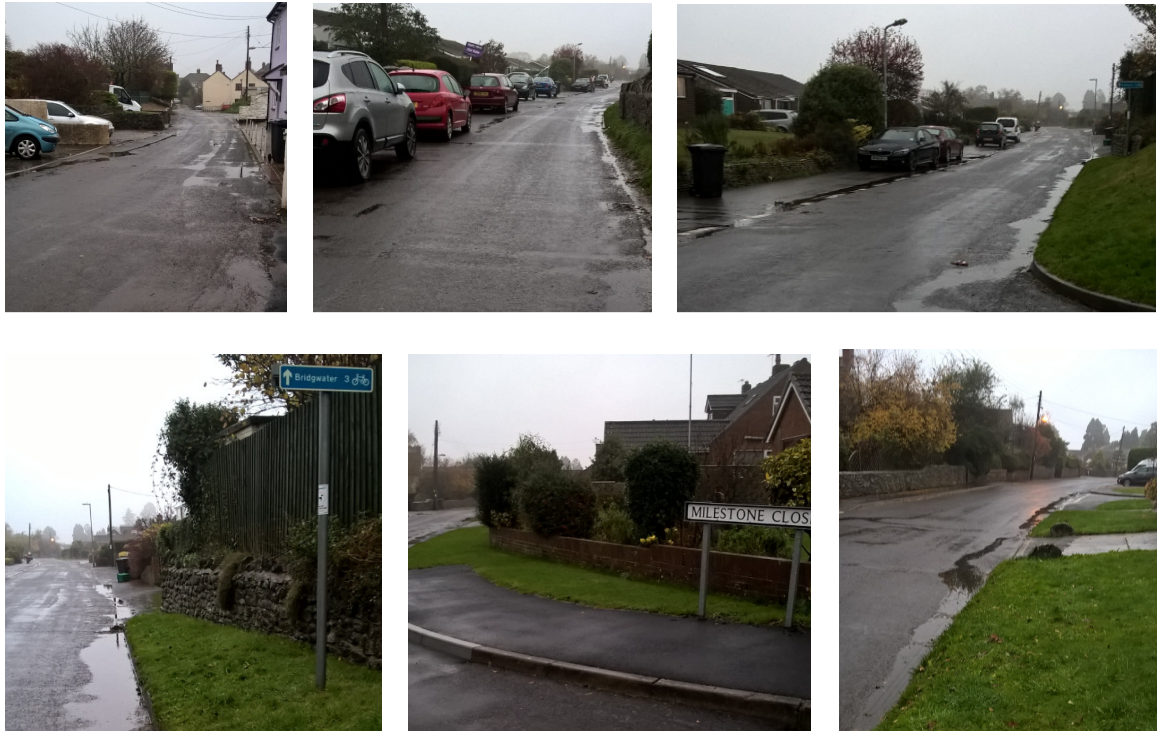
The RSO walked in the carriageway to Butts Corner, noting parked cars on the near side.

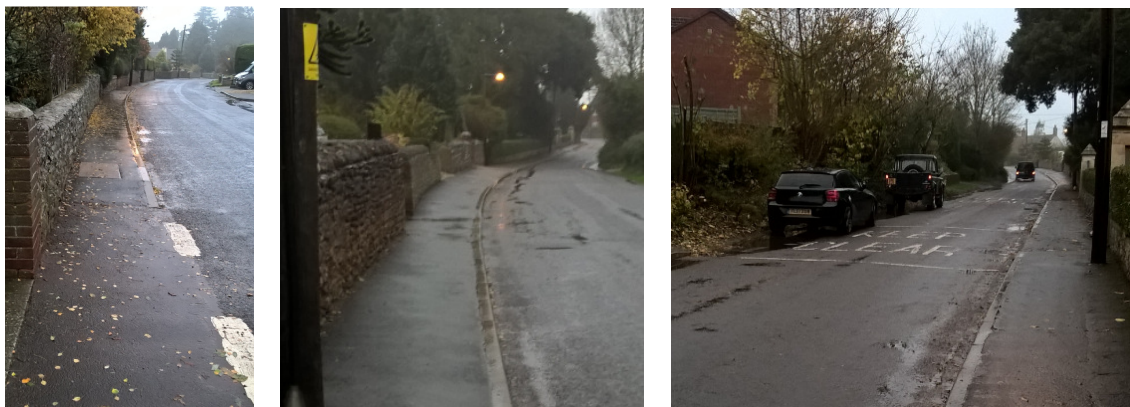
A footway commenced at property number 23.

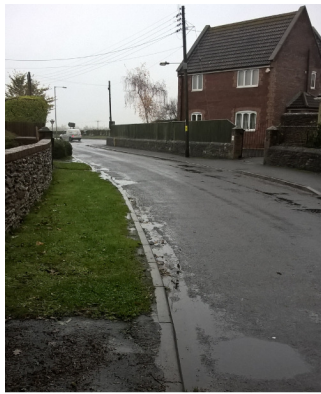
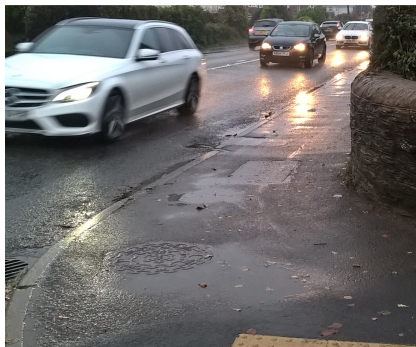
Nearing the junction with the A38 the footway switches from the northern side of the carriageway to the southern side of the carriageway. The RSO crossed the road, visibility was considered acceptable for the observed traffic speeds and the traffic flow was considered to be very low.

The RSO reviewed the visibility at the uncontrolled tactile paving landing area at the southern side of old road, looking back towards northeast bound traffic on the A38 and noted 6no. 6m hazard marking modules could be viewed, therefore an approximate visibility distance of 36m.

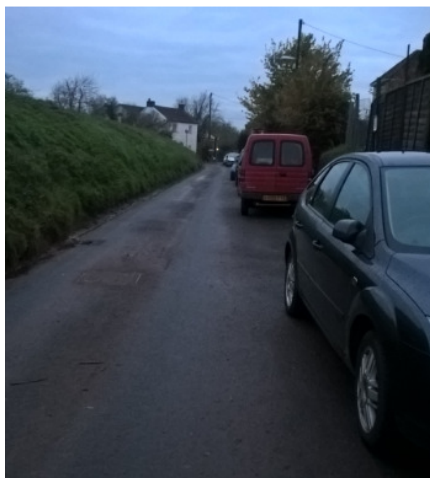
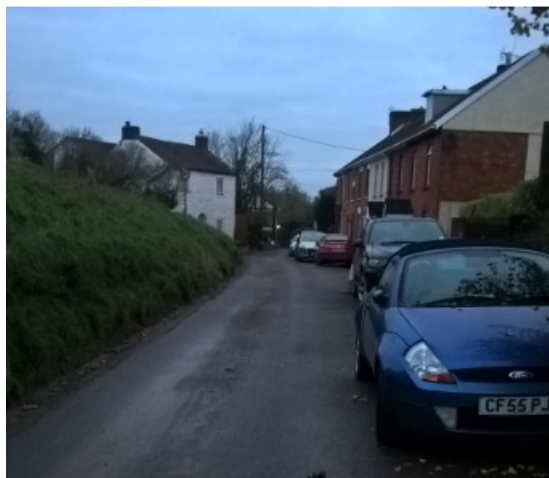
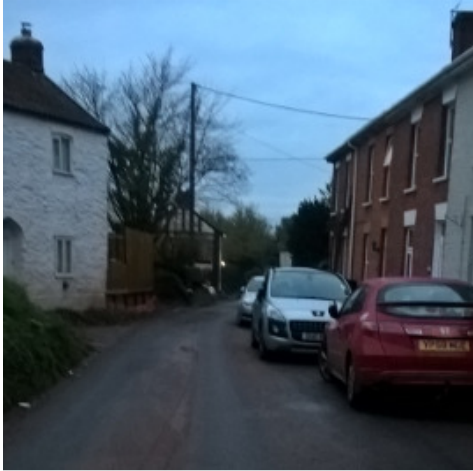
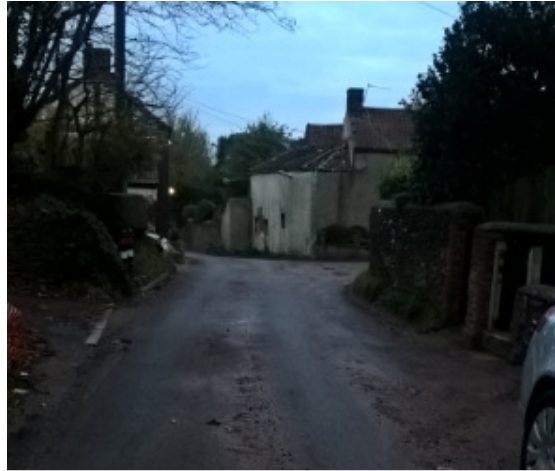
Shovel Lane is a very narrow, single track lane. There was a considerable amount of on street parking. At the time of inspection very few vehicles were driving along the lane. The RSO noted that there was limited step offs available and commenced the walked route in the carriageway. Visibility between traffic and pedestrians was considered acceptable.

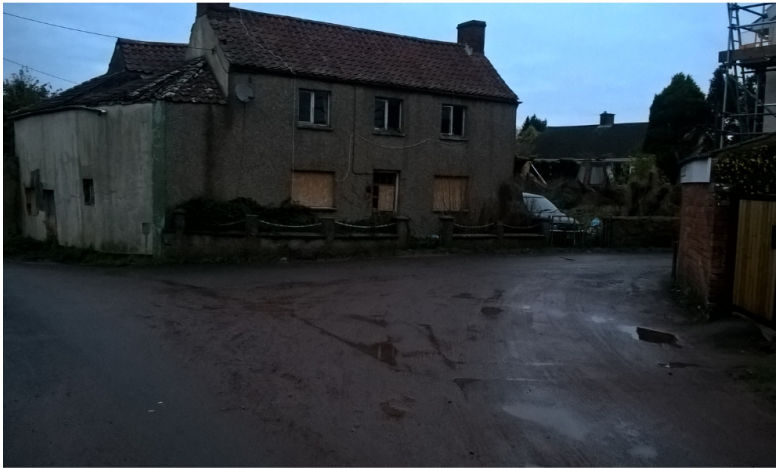
The RSO turned from Shovel Lane into Hyde Park.

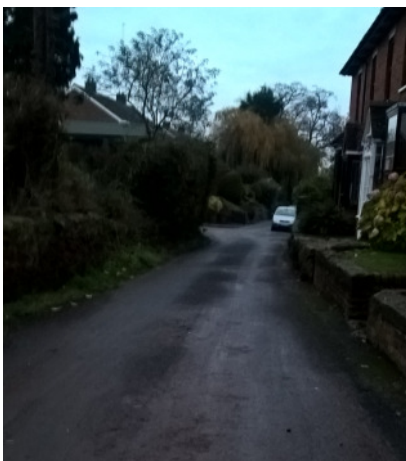
The start of Hyde Park the carriageway is bounded by boundary walls.

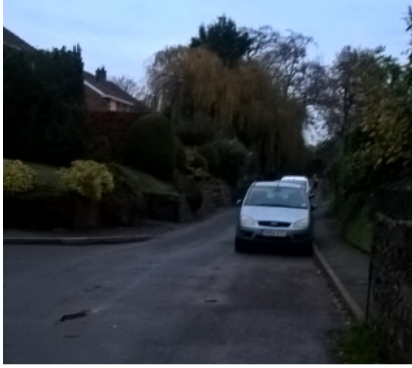
A footway commenced opposite the junction of Hyde Park with Hyde Park Avenue.

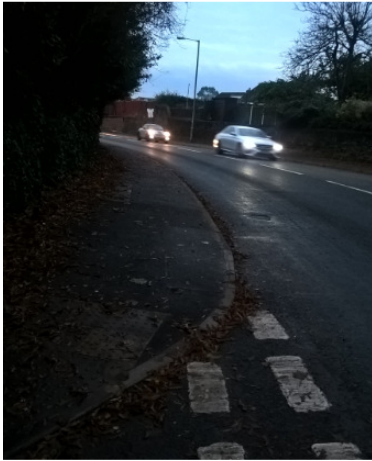
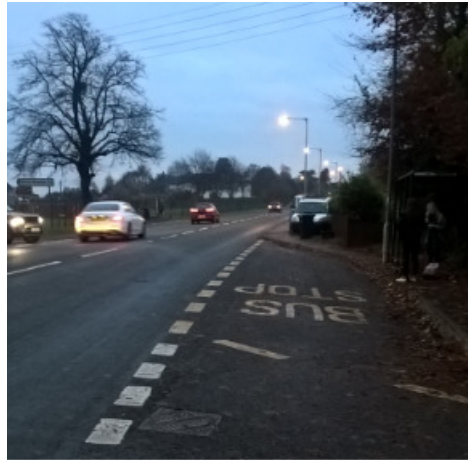
Pedestrians were observed walking in the carriageway. The footway continues to the junction of the A38.

At the junction with the A38 a footway continues northbound towards North Petherton Town Centre. A footway southbound leads to a bus stop, where young people were waiting for a bus.

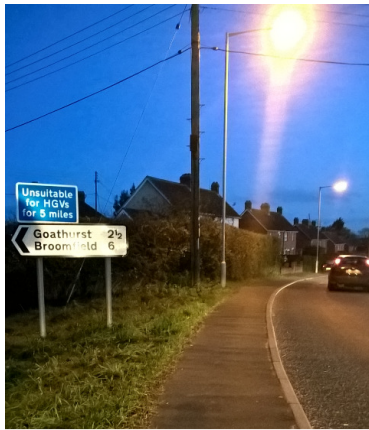
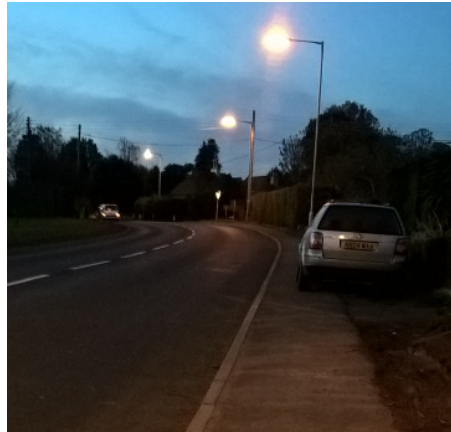
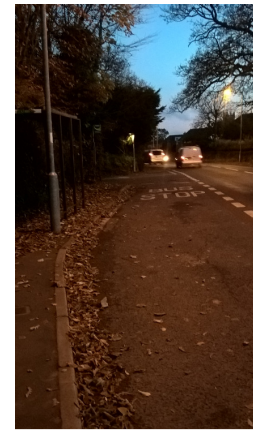
The RSO walked on the footway located on the westerly side of the A38 and continued in a northerly direction.

Vehicles parked on the footway force pedestrians to walk adjacent to the kerb line increasing the risk of them being struck by passing vehicles. Such parking would completely obstruct the passage of mobility impaired pedestrians (inc. wheelchair and pushchair users). Near the junction of Hyde Park is a bus stop. There is a tactile paved uncontrolled crossing across Hyde Park.

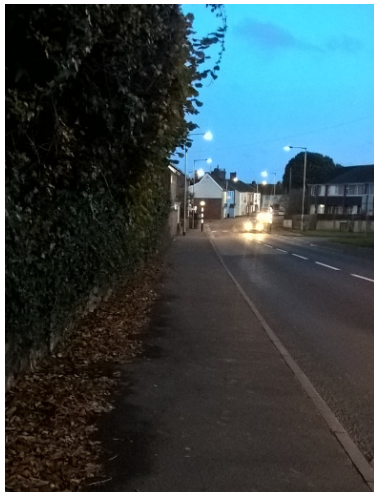
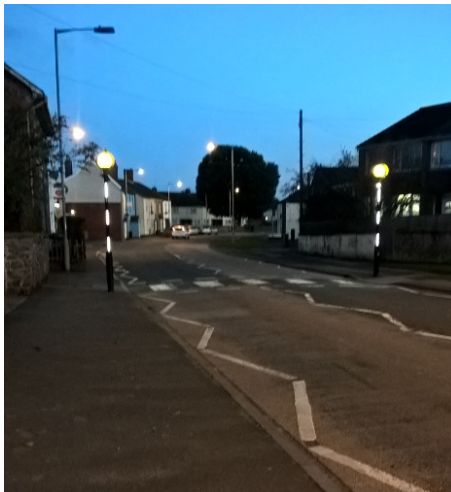
The footway widens, with a hedge slightly overgrowing the boundary wall and leads to the controlled zebra crossing. The zebra crossing was conspicuous with illuminated poles and beacons. The RSO noted visibility to be acceptable and considered the crossing to be an appropriate form of controlled crossing of the major road.

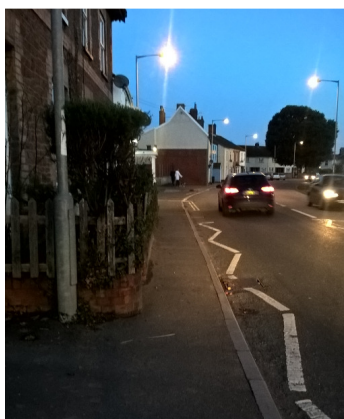
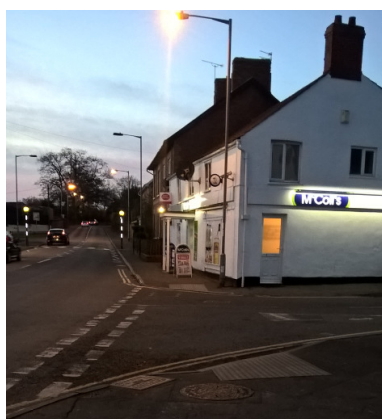
Continuing on the western footway the footway narrows between the Zebra crossing and the shop. The RSO crossed Tappers Lane; at this point the footway is at a lower level than the carriageway, constructed using a system of back to back kerbs and a longitudinal drainage channel.
