# **Walked School Routes - Robert Blake Science College, Bridgwater**

**SA-8-0039-002-1**

**Admissions and Entitlements Team**

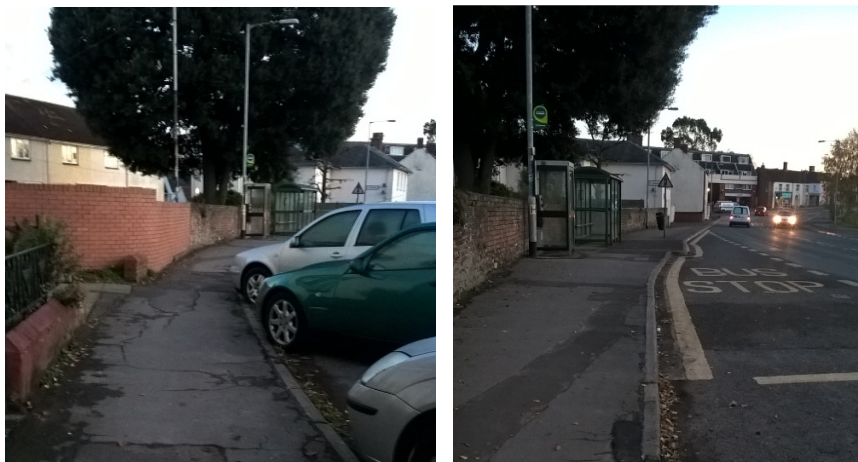
The RSO observed a layby where road users have adopted an echelon parking format. The footway widens near the bus stop.

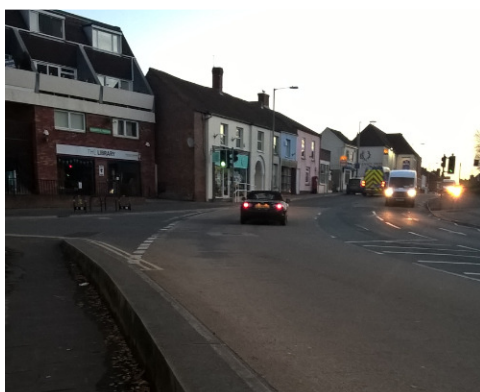
Continuing along the route (outside No. 21), a concrete plinth grade separates the footway from the carriageway. Hatching commences in the centre of the carriageway for a right turn lane.

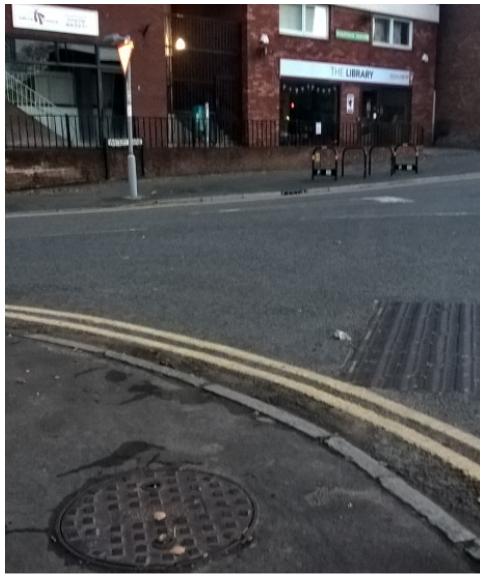
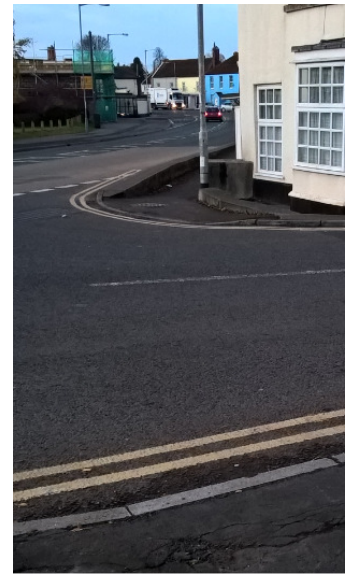
Crossing Watery Lane, there is no formal uncontrolled crossing (normally identified by tactile paving). When walking north bound the RSO noted that visibility to the left was restricted. The RSO crossed with caution. Young people crossing this carriageway, within the walked route guidance should be accompanied, as necessary. When accompanied, the RSO considered that this uncontrolled crossing could be crossed by a young person in reasonable safety. Further consideration may be given to improving this crossing in the future. The School Admissions Team should liaise with the SCC T&TDG LSTF schemes engineer, to discuss the feasibility of any engineering solutions to improve safety at this crossing point. The volume of traffic using Watery Lane at the time of the inspection was very low.

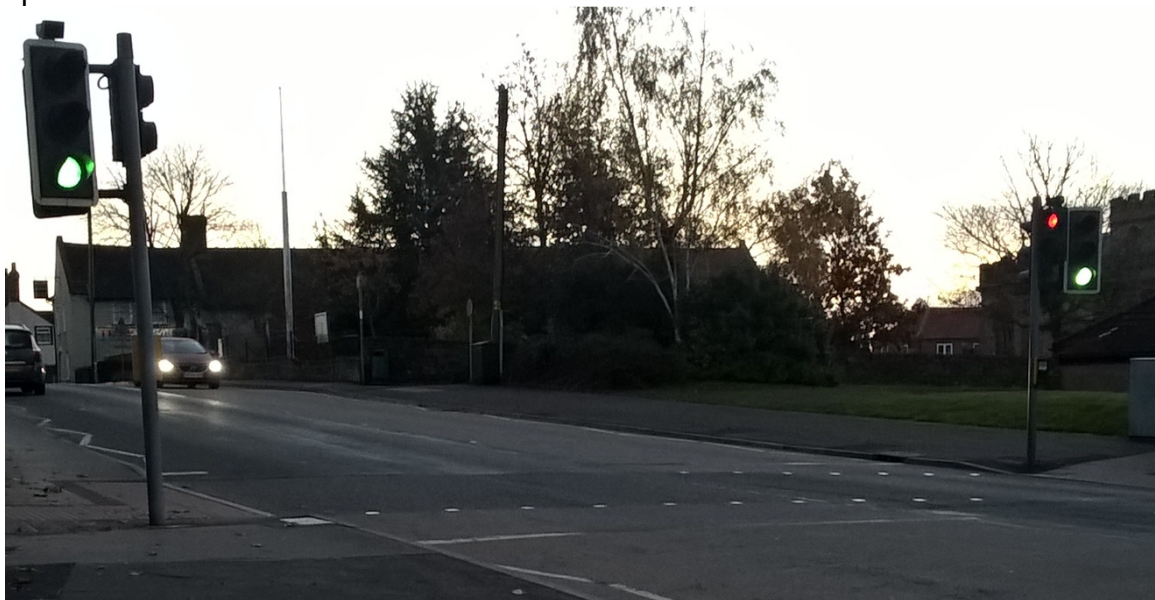
There is a pelican controlled crossing outside of the Library. Visibility at the pedestrian crossing landing areas appeared acceptable for the observed approach speed of traffic.

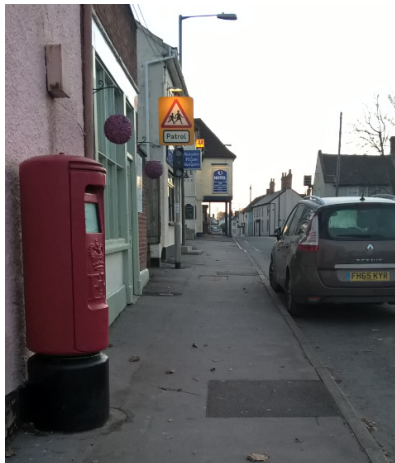
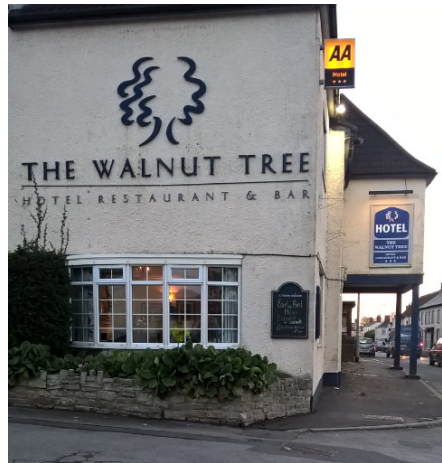
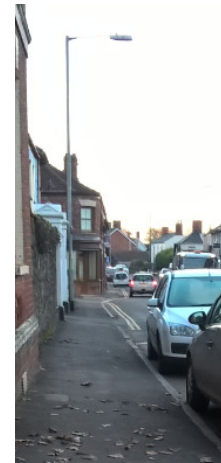
Approaching the Walnut Tree hotel, there is a school 'patrol' warning signs and associated wig-wag lights. Parked vehicles create a physical segregation between moving traffic and pedestrians on the footway.

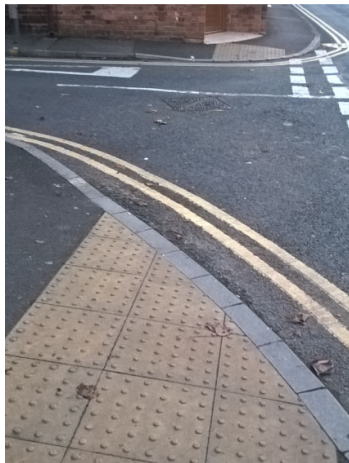
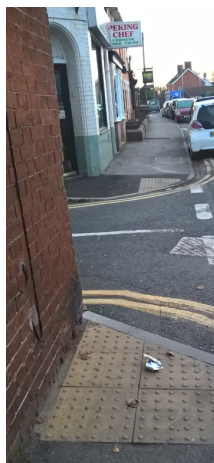
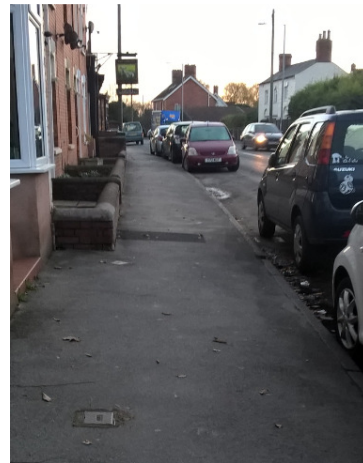
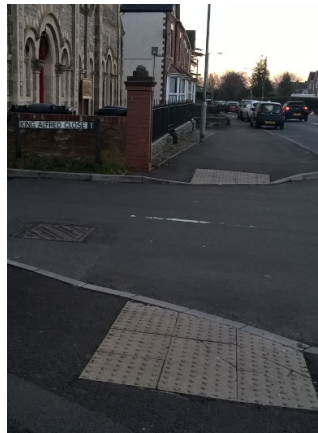
The RSO crossed several minor side streets (Clare St, Queen St, King Alfred Close) with restricted traffic flow and speed. The RSO noted vehicles parking on the footway and the footway widening out at the bus stop (see previous comments about inconsiderate footway parking).

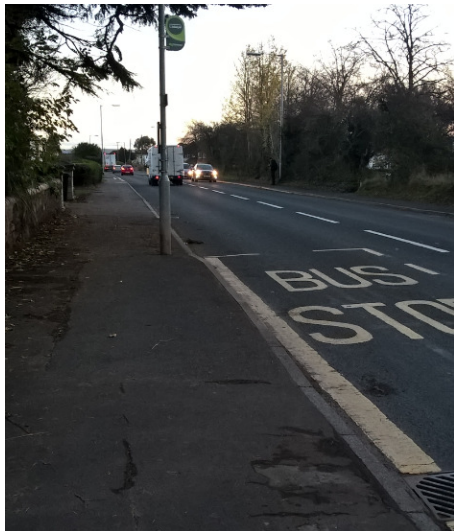
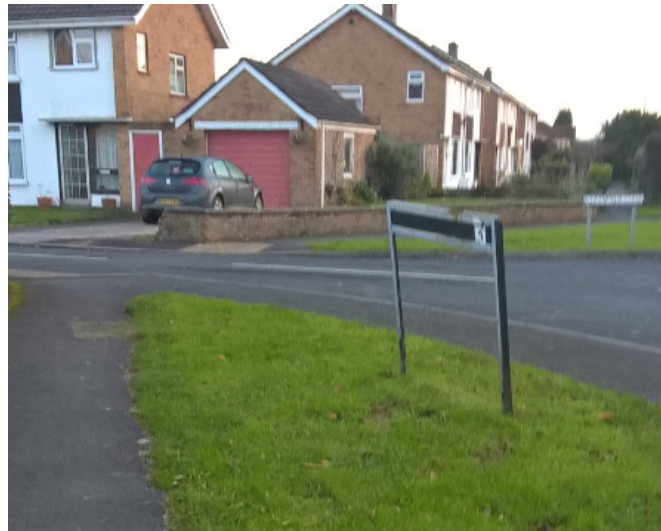
The RSO noted that the footways widened out at the bus stop and an uncontrolled tactile paving crossing is set in to Heathfield Close.

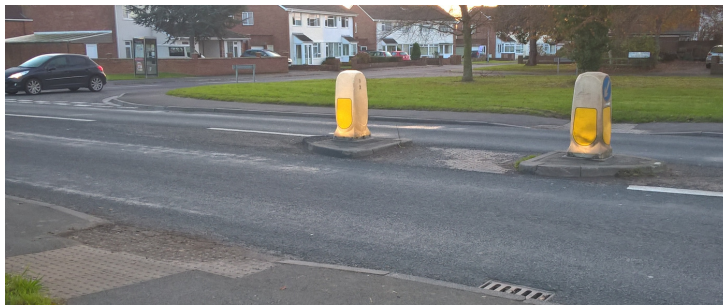
Walking from the pedestrian refuge (A38 near junction with Baymead Lane).

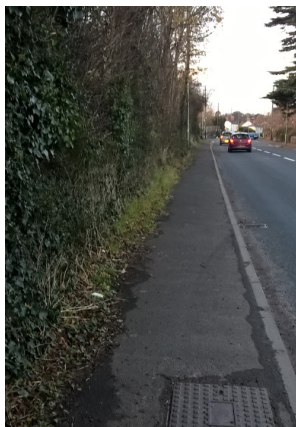
The RSO noted that the back edge of the footway was bounded by hedgerow.

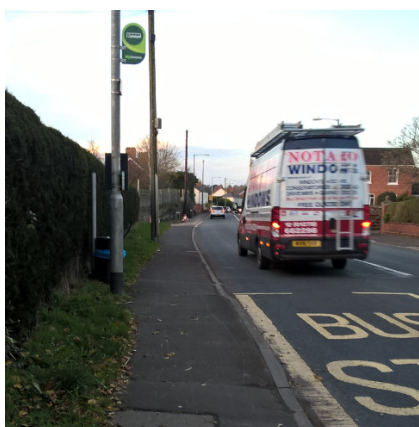
At the junction of Baymead Lane, the RSO noted that it is a wide junction to cross and no tactile paving has been provided in association with the dropped kerbs. The T&TDG LSTF scheme manager should give further consideration to this.

Item 2.2.2.6 identified several uncontrolled crossing points within North Petherton that would benefit from engineering improvements to assist visually and mobility impaired pedestrians. It also highlighted the omission of intermittent longitudinal safety lines at bus stops. It is recommended that this report be reviewed by the T&TDG LSTF schemes manager.

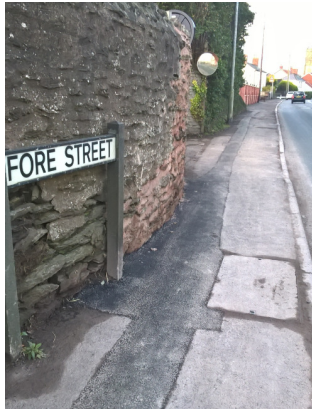
The RSO continued along Fore Street.

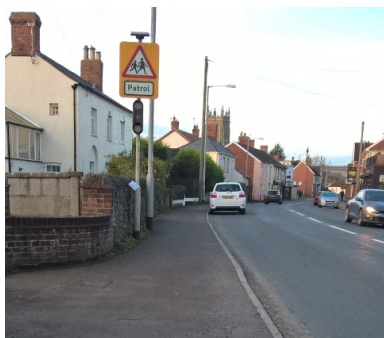
The RSO observed 'on street parking' on both sides of the road. The carriageway was side enough to maintain a two way traffic flow.

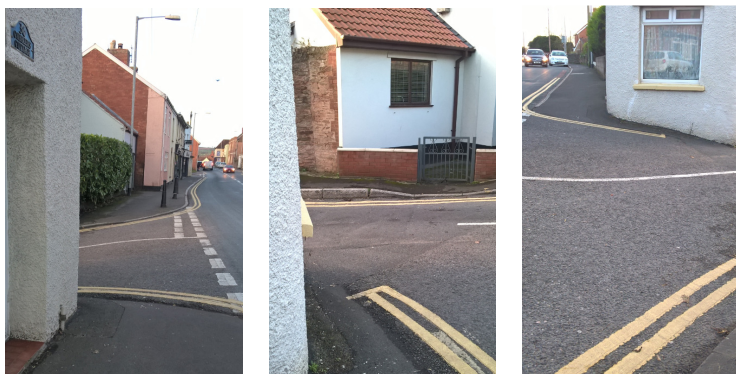
The RSO crossed lane near 'Cobblers Cottage' (opposite Lamb Inn), there is no tactile paving at this point and restricted visibility westbound, good visibility eastbound. No traffic observed using the lane at the time of the inspection. The T&TDG LSTF scheme manager should give further consideration to this.

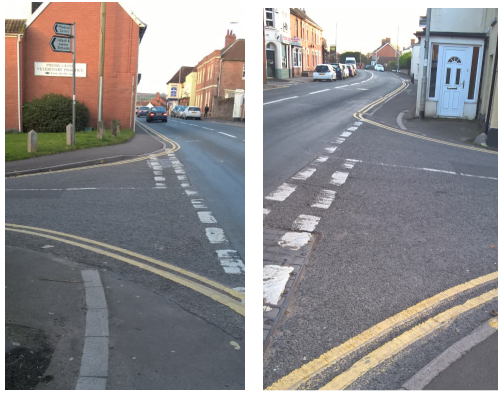
The RSO crossed side road to primary school and noted: no tactile, visibility restricted in westbound direction. The T&TDG LSTF scheme manager should give further consideration to this.

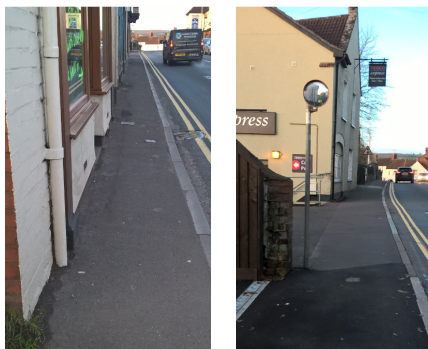
The footway narrows over a short length and widens outside the Tesco store.

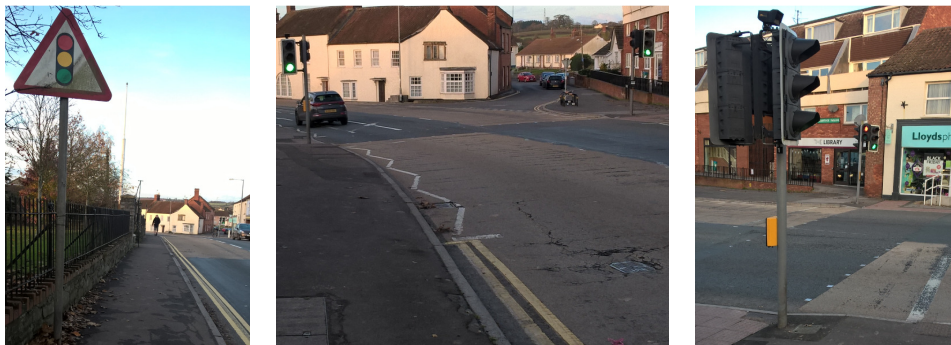
At the pelican crossing outside Lloyds Pharmacy, visibility was considered acceptable. The vertical alignment (west bound approach) of the carriageway, dips down and into a left hand bend. An advanced warning sign located approximately 60m east of the crossing, heightens driver awareness to the crossing ahead.

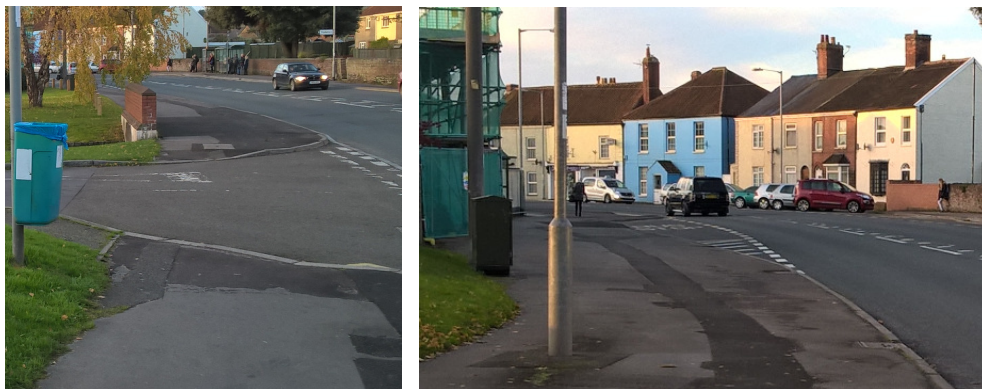
Crossing the car park entrance, the RSO noted: the absence of tactile paving. The footway widens at the back of bus stops.

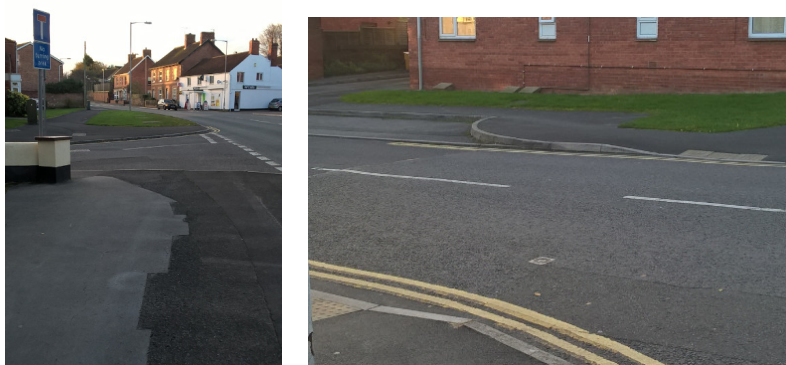
An uncontrolled crossing is inset into Hammett Street.

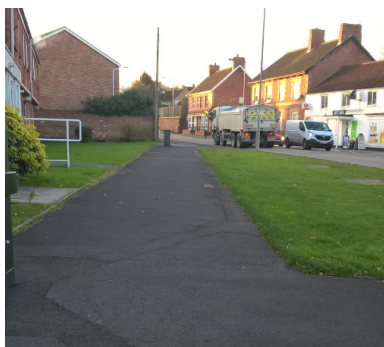
The footway is segregated from the carriageway by a grass verge outside Francis Bastin House.

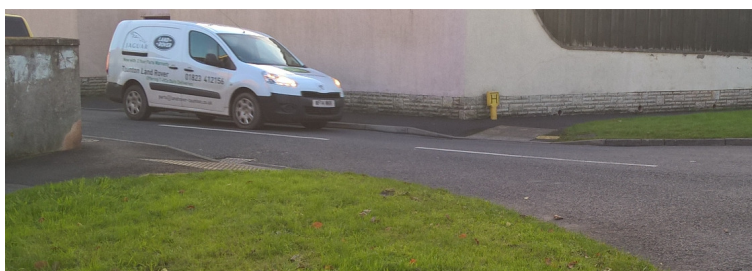
An uncontrolled tactile crossing inset into Crosswell Close.

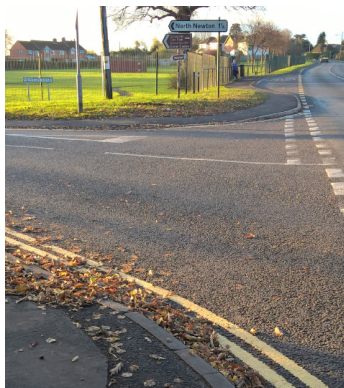
There was no uncontrolled tactile crossing of Newton Road. The RSO observed several vehicles turning into Newton Road. A crossing would need to be appropriately located to maximise visibility between pedestrians and motorists negotiating the junction. The T&TDG LSTF scheme manager should give further consideration to this.

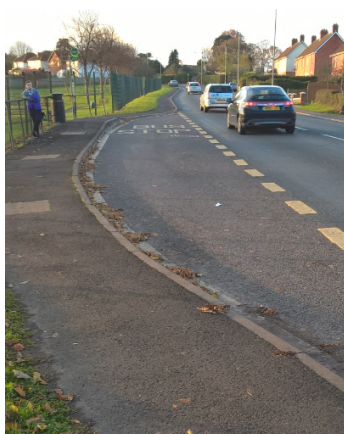
Taunton Road A38 – At the bus stop an intermittent longitudinal line is omitted. The T&TDG LSTF scheme manager should give further consideration to this.

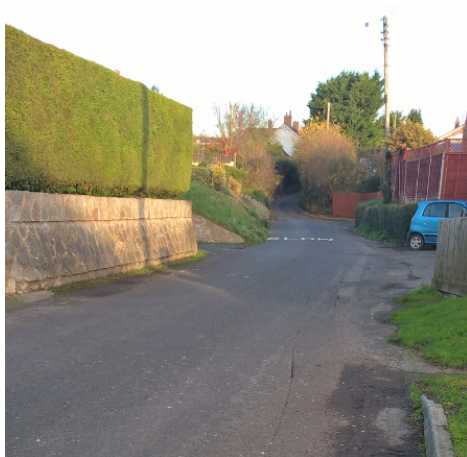
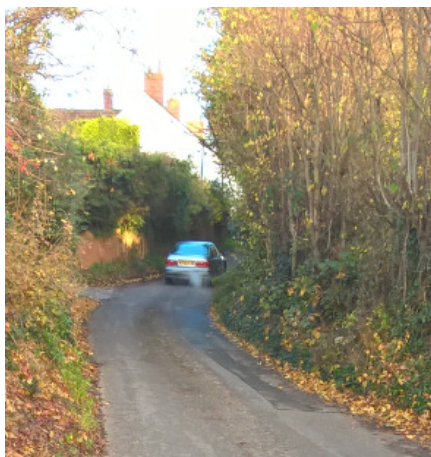
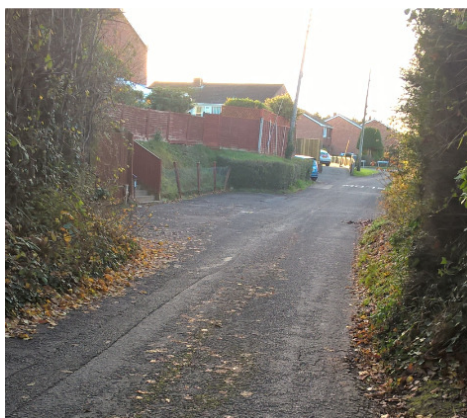
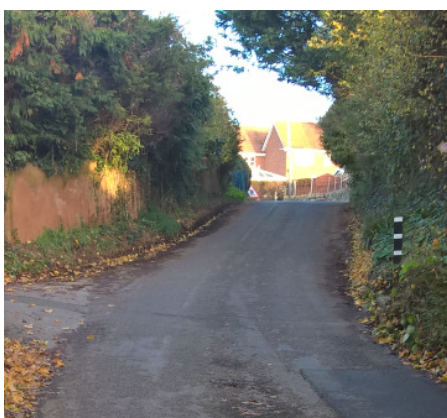
There is a right hand bend bound by verge / hedge. The RSO considered visibility to be acceptable when walking on the outside of the bend. There was a very low traffic flow at the time of the audit.

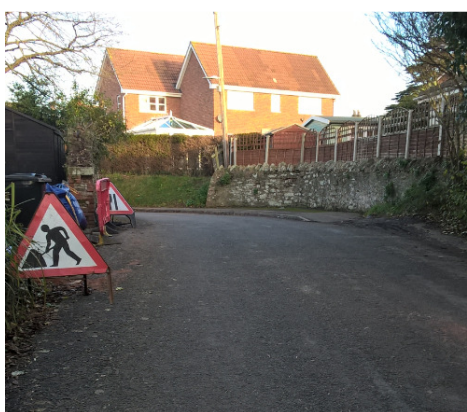
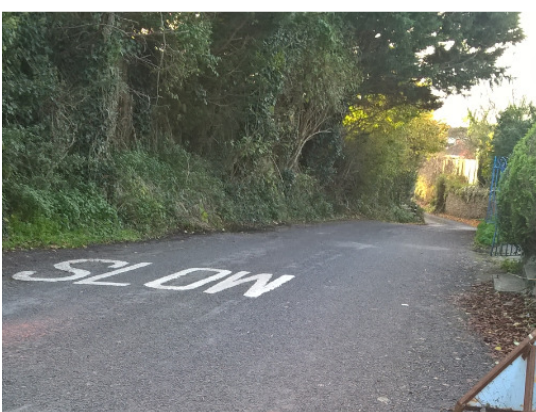
The predominant amount of vehicles were travelling outbound (northerly direction). A footway commences opposite Baymead College (No.2, Baymead Lane).

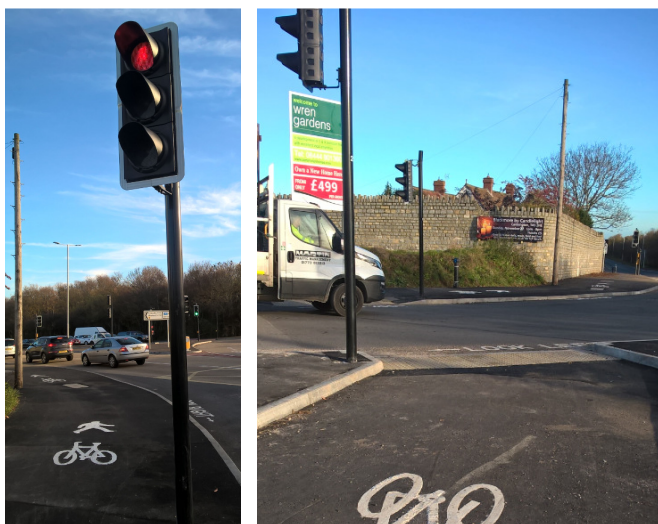
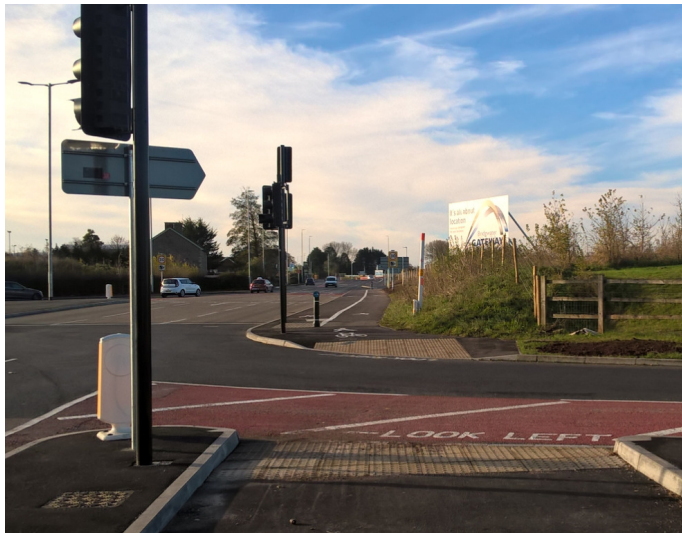
The RSO noted that these works have been designed and constructed to provide a defined pedestrian route across the arm of a major roundabout. The crossing is uncontrolled on both the exit and entry to the roundabout. The roundabout design and associated footway infrastructure will be subject to an independent road safety audit.

It is recommended that the School Admissions Team contact the project sponsor to ensure outstanding works (identified through the Road Safety Audit) to address any safety concerns are completed prior to this route being considered acceptable as a suitable walked route.

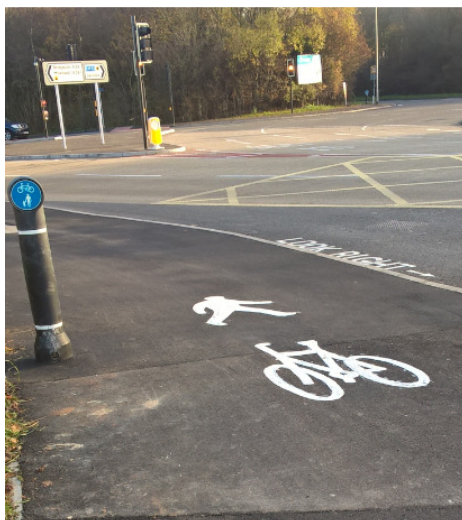
The RSO observed that some of the works remained incomplete at the time of inspection, for instance, the removal of the old look right markings, reinstatement of a safety line to define a margin of lateral clearance away from the kerb edge for cyclists.

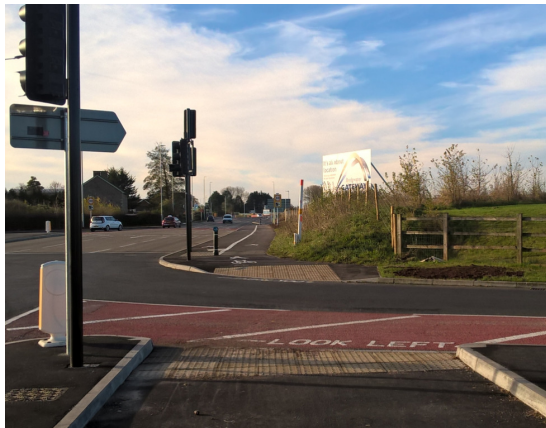
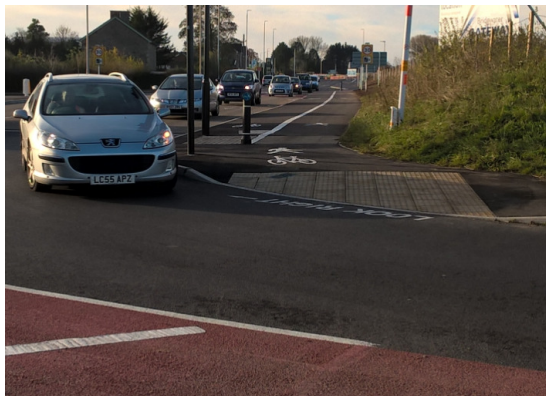
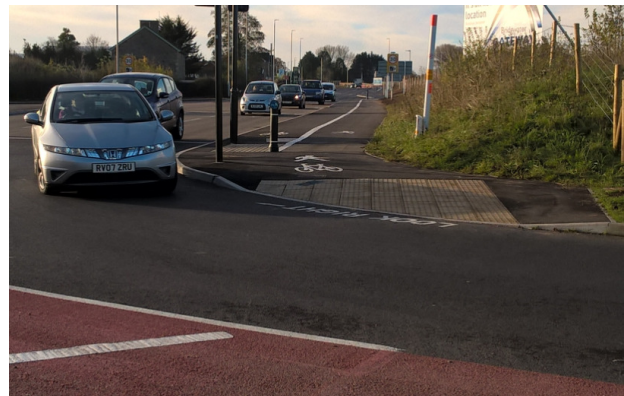
Pedestrians walking in a northerly direction must be vigilant of traffic manoeuvres when using the uncontrolled crossing across the exit to the roundabout. The RSO observed that the nearside, northbound lane is for ahead and left turning traffic. Not all left turning vehicles used their traffic indicators.

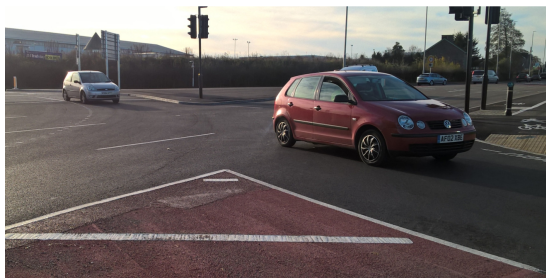
Vehicles exiting the roundabout are also controlled by traffic signals on the roundabout.

The footway across the Huntworth Roundabout is deemed adequate and the roundabout splitter island enables the pedestrian to cross the road in two stages.

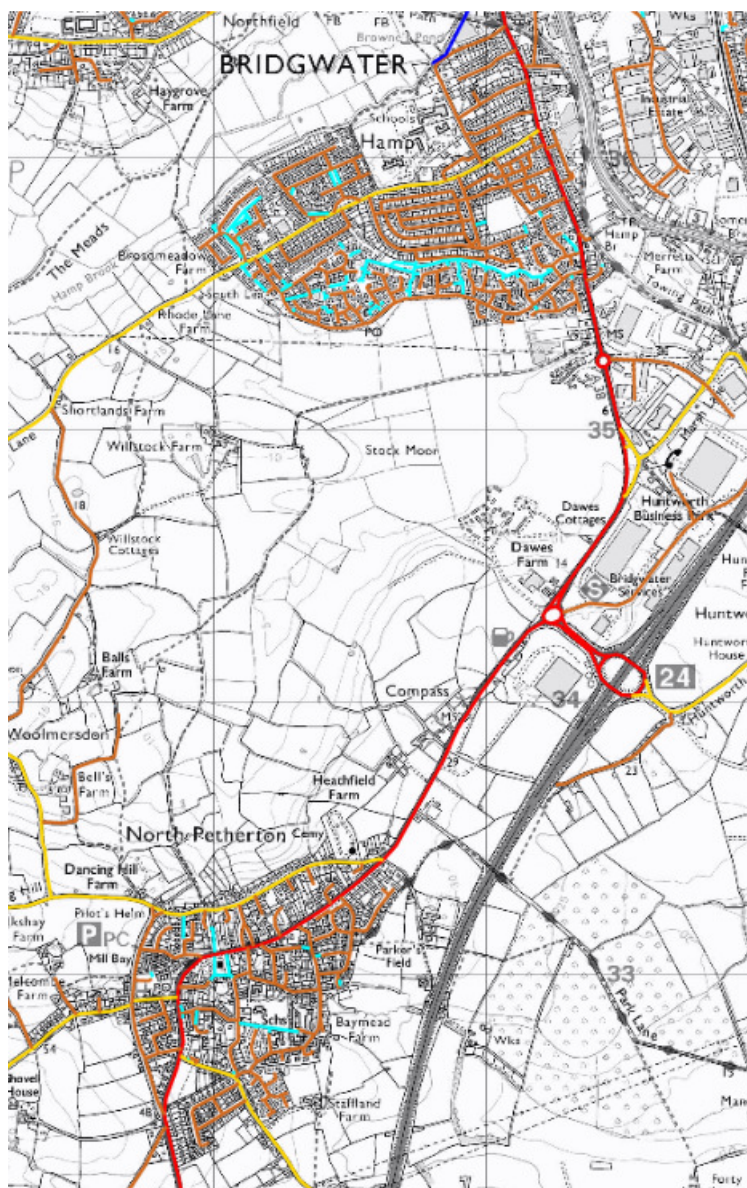
### Route Classification

Brown: 'D' Class  
Yellow: 'C' Class  
Green: 'B' Class  
Red: 'A' Class
